BOILER TUBE FAILURE ANALYSIS IN 210MW POWER PLANT STEAM BOILER

Abstract- This study is aimed at analyzing the reasons associated with boiler tube failure. Inspection and data collected from MTPS - I serve as the basis for this analysis. Three samples (damaged LTSH tube, failed Economizer tube and failed RH tube) were collected from MTPS. Metallographic investigations were carried out in the samples collected to understand, interpret and substantiate the probable reasons that led to tube failure which occur when the effective strength falls below a critical level. Apart from visual inspection, optical microscopy, micro-hardness tests, SEM investigations, chemical analysis and EDS tests were carried out on various regions of the failed tubes and the results have been elaborately discussed. Upon visual inspection, formation of oxide layers on the inner side of the tube has been noticed which indicated that the inner side of the tube is subjected to corrosion. Formation of oxide layers has led to inhomogeneous overheating which has thereby affected the homogeneity of the tube. The main reason for rupture (hole formation) in the failed region can be attributed to steam erosion either f

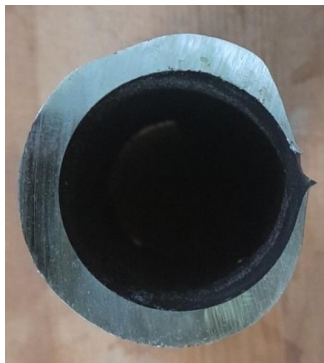
By observing cross section of the economizer and RH tube, it could be noted that half of the cross section of the tube segment was thinner than the other. Figure 3.1 (a) & (b) presents image after making a single cut along transverse plane of failed economizer and RH tube respectively

Figure 3.1 (b): Cross section at the failed region of Economizer tube.

A1	B1	C1	D1	E1	F1
1.34	6.48	6.40	5.58	6.10	4.19

Upon thinning, the tube could have failed due to following two reasons:

1. The reduced thickness could not withstand the circumferential hoop stress and caused stress rupture.
2. Thinning might have caused over heating which has led the metal temperatures to exceed their creep temperature limit.

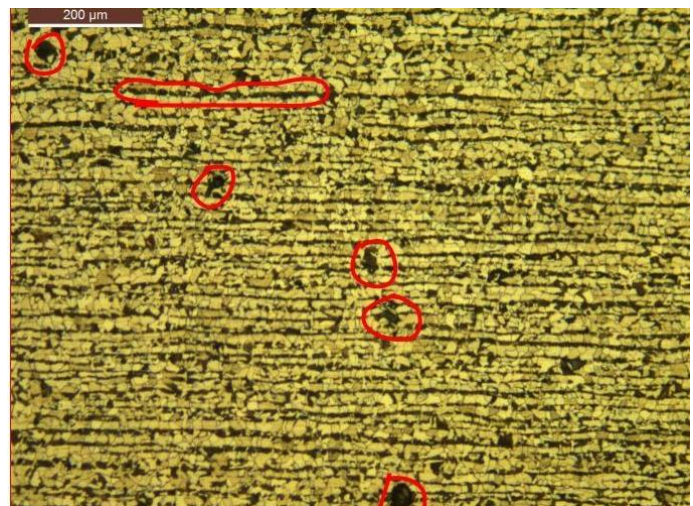
Figure 3.2 (b) More affected region of Economizer tube

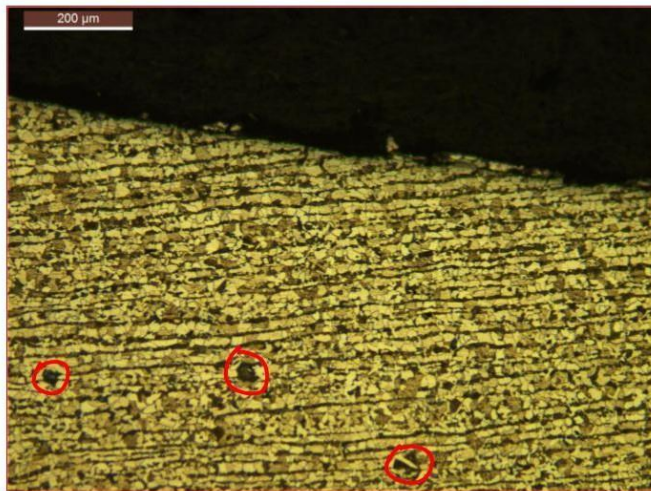
Figure 3.2 (c) More affected region of RH tube with significant graphitization

3. Since, "chromium forms more stable carbides than that of iron and molybdenum", usage of boiler tube materials with high chromium content can withstand graphitization which is one of the most predominant failure mechanisms identified via microscopic examination.

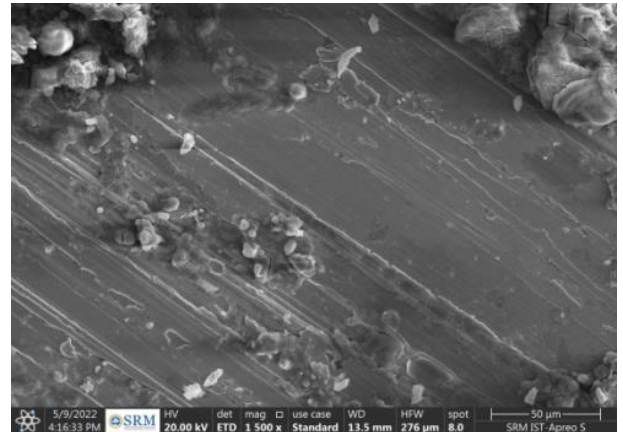
Figure 3.4 (a) SEM micrographs of Economizer tube

By referring the SEM micrographs, we could observe the formation of graphite nodules which confirms the occurrence of elongated as well as spherical graphitization. We could also observe the formation of micro-voids and void coalescence along with micro-cracks and their growth. Since the main purpose of doing SEM in our project is to ascertain the formation of graphite nodules, micro-cracks and void coalescence which occurs due to diffusion of carbon as a result of overheating accompanied by creep, we have done SEM on un-etched specimens. There is a huge scope for researchers to extend our SEM investigation with specimens after applying various etchants so that the formation of new grains with different microstructures can be observed and appreciated.

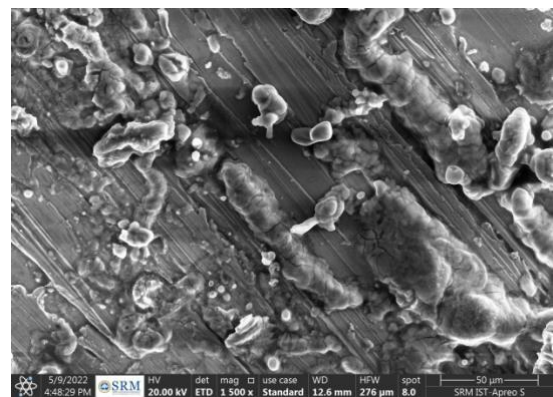
Figure 3.4 (b) SEM micrographs of RH tube
