# Case Study of Structural Rehabilitation of Multi Storey Residential Building

**Abstract** - Although the RCC structures are designed as per codes not always constructed properly using correct techniques and methods. As a result, the structures start showing signs of distress which requires repair and rehabilitation work. In this project, a case study of (G+7) multistoried building whose ground floor was damaged due to the flood of 2006 has been represented. The repair strategy was to assess the quality of structural members of the ground floor of the building with the help of Non-Destructive and Semi Destructive Tests such as Rebound Hammer, UPV and Concrete Core Test. All the flood-affected members were tested and proper treatment to each of them was applied such as anticorrosion coating, injection grouting, micro concreting and also jacketing of columns at ground level. Strict quality control in materials and workmanship was adopted. All the rehabilitation work was done to increase the durability and service life of the building. After the engagement of all the professionals and cooperation of the residents for rehabilitation work was carried out. Some of the recommendations a

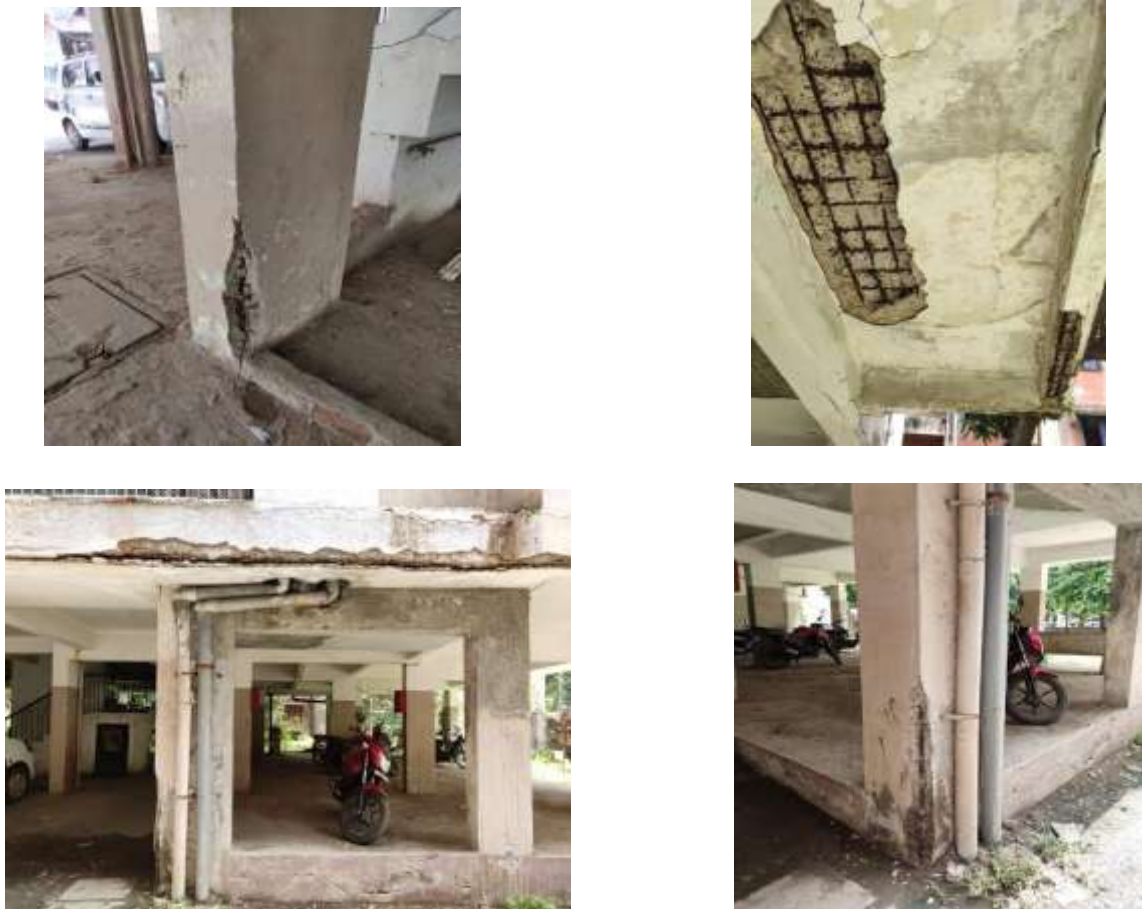
- As Akshar Plaza I is located at the bank of River Tapi, it is vulnerable to the flash floods caused due to excess rainfall and surface runoff.
- The existing condition of the building shows signs of deterioration of ground floor columns due to ageing, leakage in sewer pipes and weathering action.
- Surat is a prone to flooding as it occurs almost every year. With the beginning of the month of September, Surat becomes prone to a huge natural disaster - the flood. The climatic records of Surat states the fact that from the year 1849 itself the city is experiencing yearly flood situations.

Figure 2 Deterioration Of Concrete In Slab, Beam, Column
