FAILURES OF STEEL STRUCTURES WITH EMPHASIS ON PRE-ENGINEERED BUILDING (PEB)

ABSTRACT: Day by day the use of steel structures is increasing in a vast pace, so there is need to design the structure in the correct standards. This research presents Findings of various types of collapse cases occurs in PEB structures. With Pre-engineered Steel Buildings industry recording growth of Compounded Annual Growth Rate (CAGR) of 15% over past decade, manufacturers and suppliers of PEB are mushrooming across India. With absence of regulatory framework, failures of PEB buildings are happening with increasing frequency. study shows that these failures may be attributed to poor engineering (design and construction), mismatch and/or absence of details in substructure and superstructure, poor manufacturing standards, use of substandard materials and most predominant being faulty erection procedures. Study of failures or impending failures show a grim picture for the industry as a whole, with all the stake holders to share their part of blame.

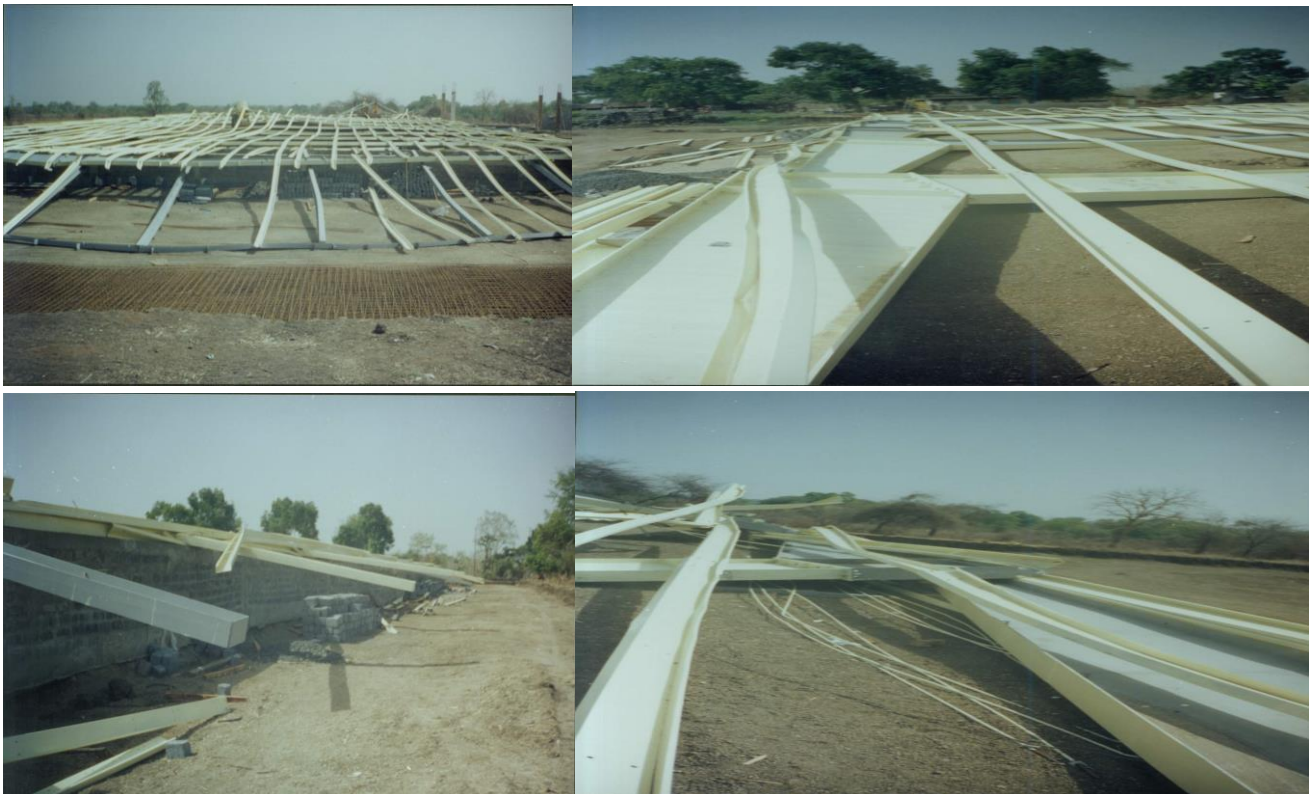
Figure 1 shows incident happened near Nagpur about a decade ago. The building was 45 m wide and 112 m long.

Incident was reported to have happened due to mild wind for few minutes during erection. Site visit showed that cross bracing rods were not provided either on roof or wall and comprised of only 12mm diameter rods lying on ground. On one sidewall, only portal columns were erected without beams, making them redundant.

Failure was along the ridge due to insufficient stability in longitudinal direction, what is termed as pack of cards failure

Fig.1 Pack of Cards Failure – Building Collapsed In Direction of Ridge.

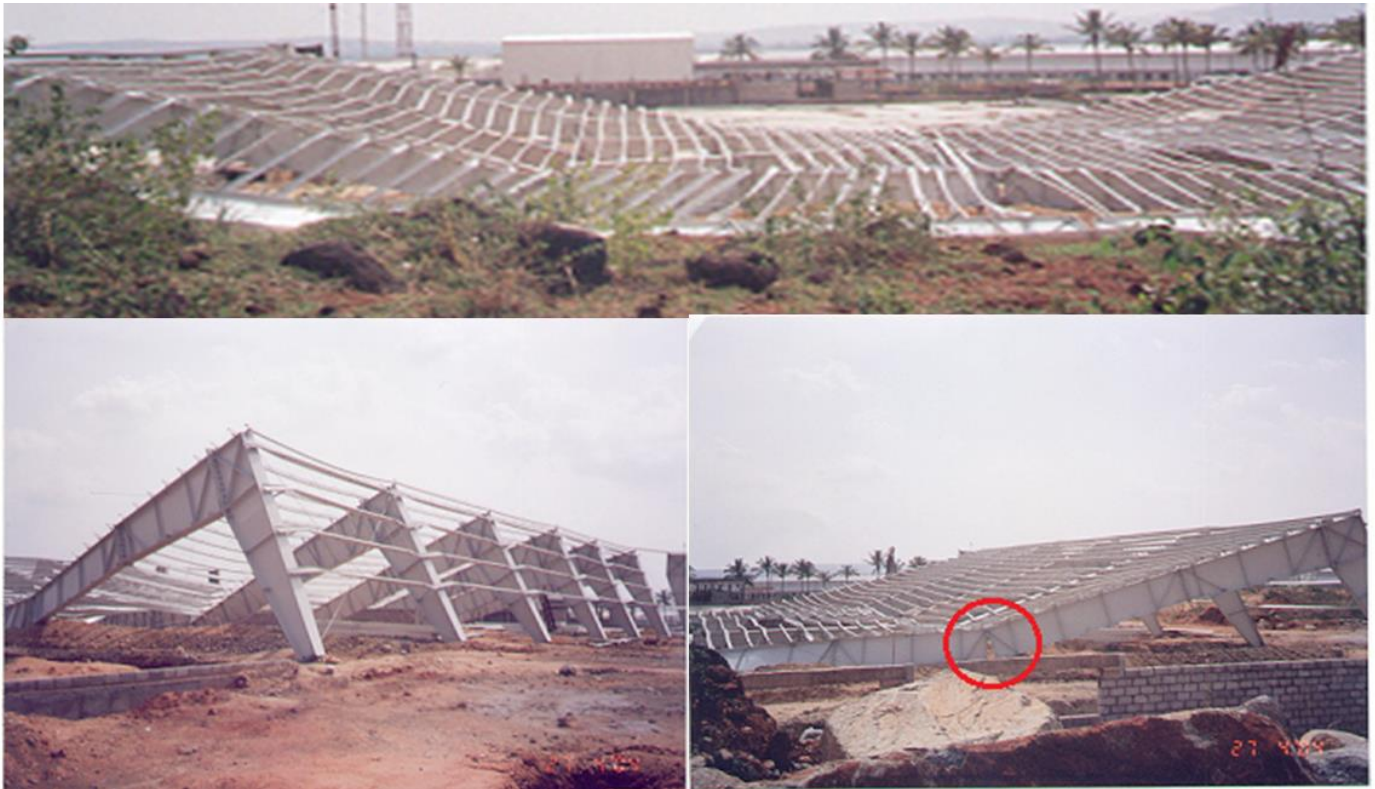
Figure 2 presents a case happened near Bengaluru. Building was about 66m wide clear span and was under erection. Collapse was due to failure of rafter splice next to knee, leading to caving in of the erected structure.

Fig. 2. Failure in Plane of Due to Rafter Splice

For wide span buildings with pin-based support, staging is recommended to be used for supporting rafter for frame erection.

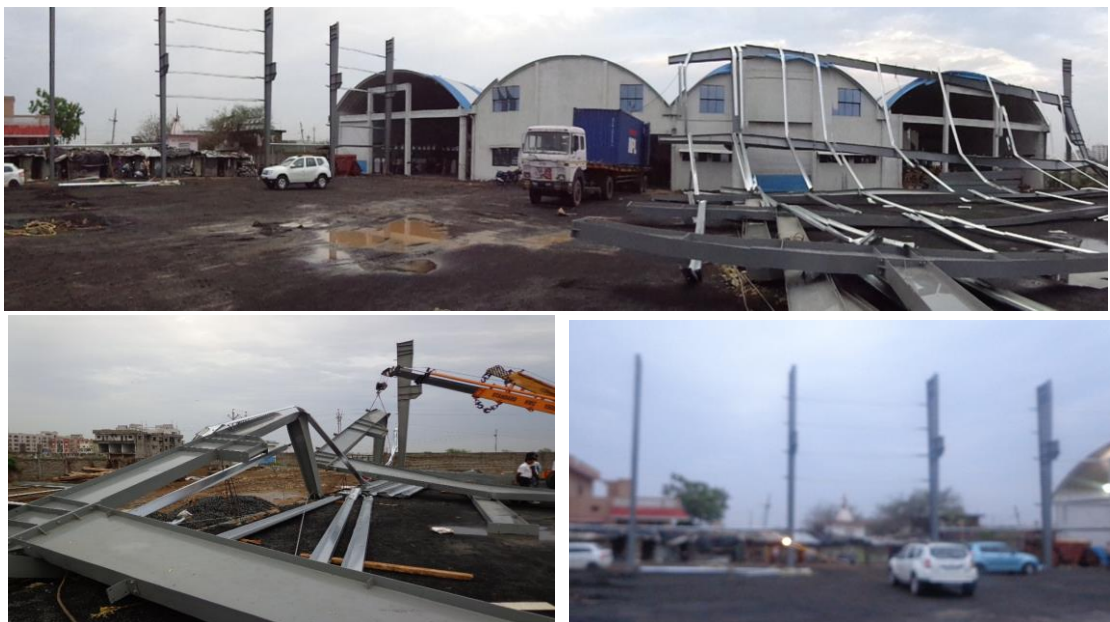
Figure 3 presents a case where collapse of a building near Nagpur, @56m wide multi-span with one interior column(BC-1). Cantilevers of about 10m length on either sidewall along roof were modelled, though were not yet erected. Collapse happened during erection and can be attributed to multiple reasons like erection of half frame, insufficient bracing and base plate of frame being above pedestal top by more than 100 mm.

Fig. 3. Building Collapse along Ridge and Unbraced Free Standing Columns

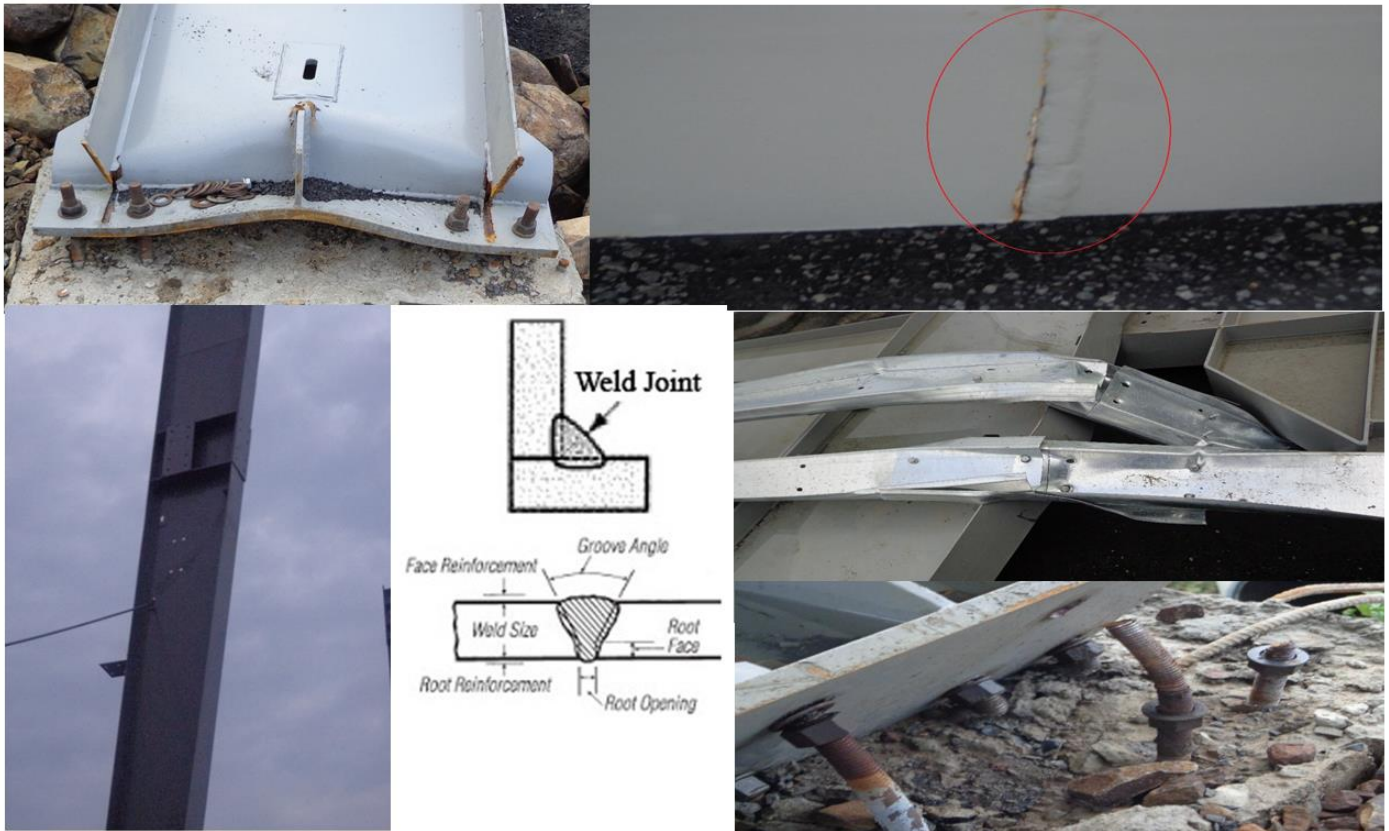
Figure 4 show many facts such as inappropriate and insufficient welding, building modelling and section

size limits conventions adopted by the industry, mismatch in design and detailing and cross bracing.

Fig. 4 Insufficient Welding, Inconsistent Detailing, Level Difference in Pedestal & Baseplate

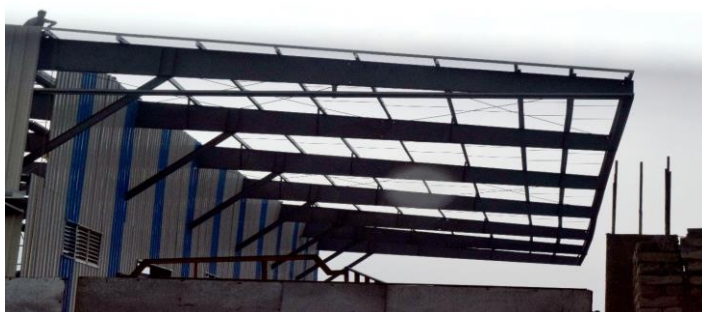
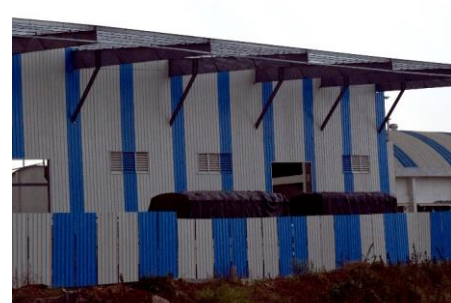
Fig. 5. Rehabilitation in Progress – Braces Added For Cantilevers

Figure 5 shows rehabilitation of building in progress. Support braces are now added to

cantilevers.

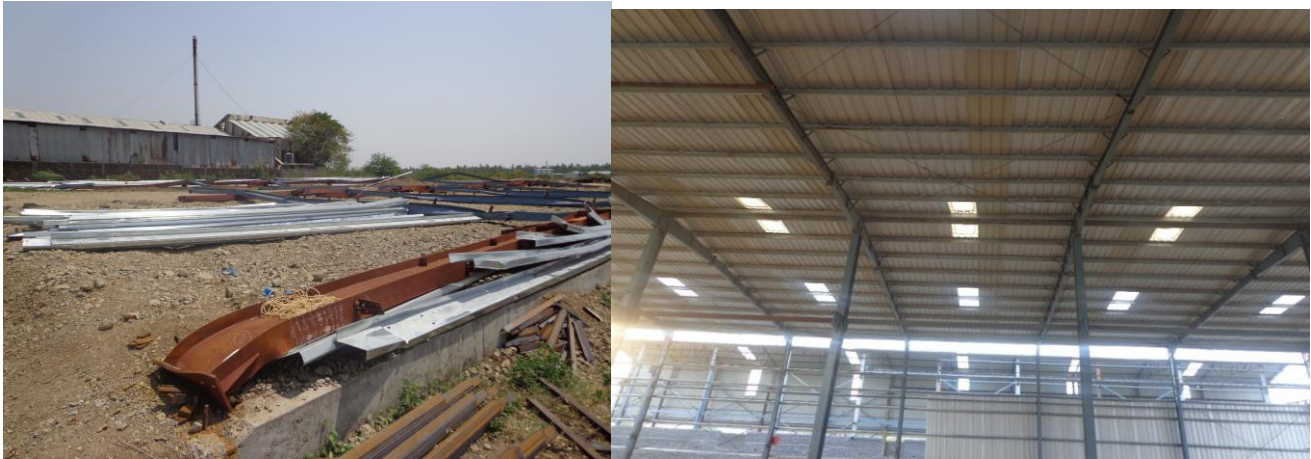
This metal building collapsed near Nagpur in 2014 and was about 30 m wide multi-span with one Design engineer, supplier of plates, fabricator of primary frame, supplier of coldformed sections and sheeting, were all different. Multiple erectors tried to erect the building, eventually it collapsed. Figure 6

interior column (BC-1) with provision for one crane of 5 MT in each isle and lean-to extension. shows the collapsed building and also rehabilitated one.

Fig. 6 Collapsed Metal Building And Partially Rehabilitated Building

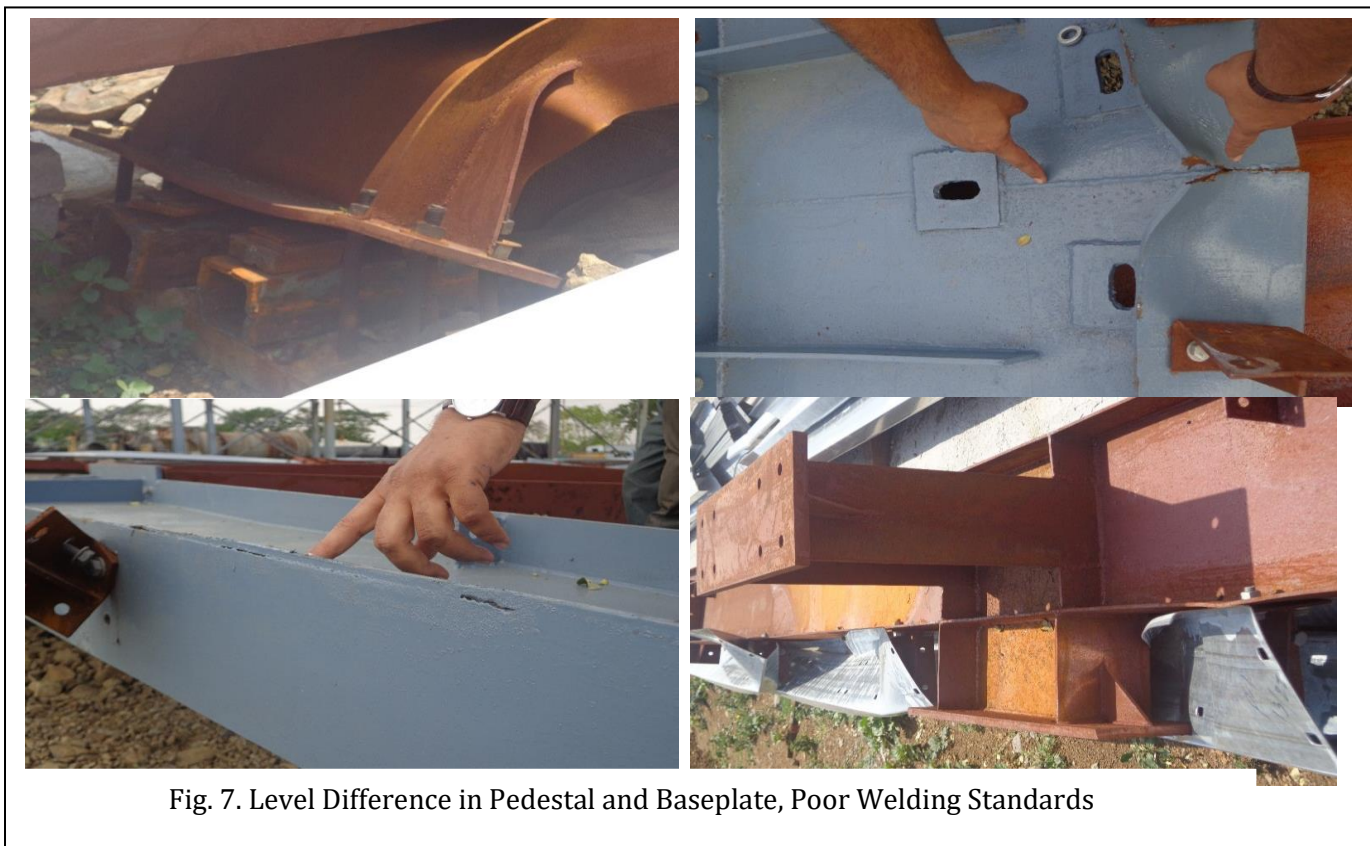
Figure 7 shows level of baseplate of column above pedestal by about 300 mm, welding strip on flange, web and flange butt welding at same cross section and member to be connected to stub with large

eccentricity. bilitated structure used same material and still had a lot to be desired on structural stability. It is a classical case to define urgent need of structural audit of the buildings.

Fig. 7. Level Difference in Pedestal and Baseplate, Poor Welding Standards

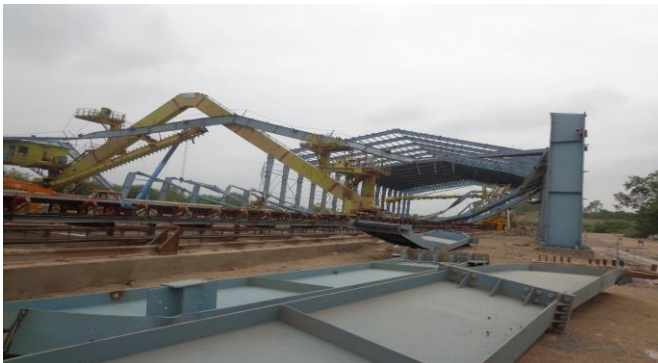
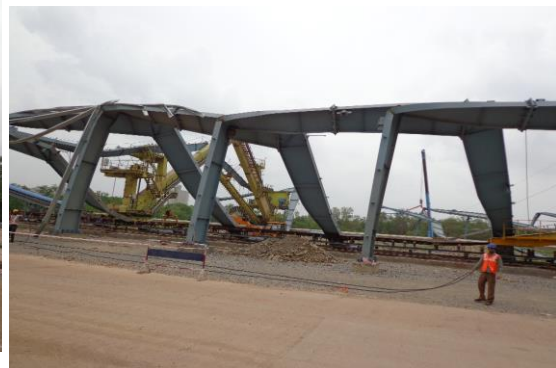
Figure 8 shows failure of another major building 57.5m wide clear span with eave height of 15m. Building collapsed in longitudinal direction, however columns deflected at the level where section properties changed. Collapse was due to delay in fixing bracing in first bay due to site conditions and next braced bay was only seventh. For walls, three

tier bracing was required.

Other non-conformities were observed as flange butt weld just above base plate stiffeners, distorted base plate and flange braces not fixed.

Fig. 8. Collapse of Wide and Tall Building along Ridge above Column Section Change

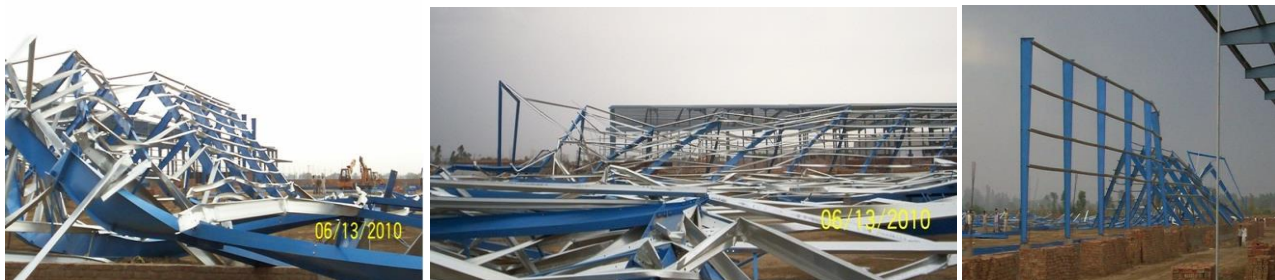
shows collapse of a building due to similar errors like erecting columns only without bracing, frames

without bracing and may be also poor engineering of frame.

Fig. 9 Collapse of a Building in Plane of Frame and Unbraced Free Standing Columns

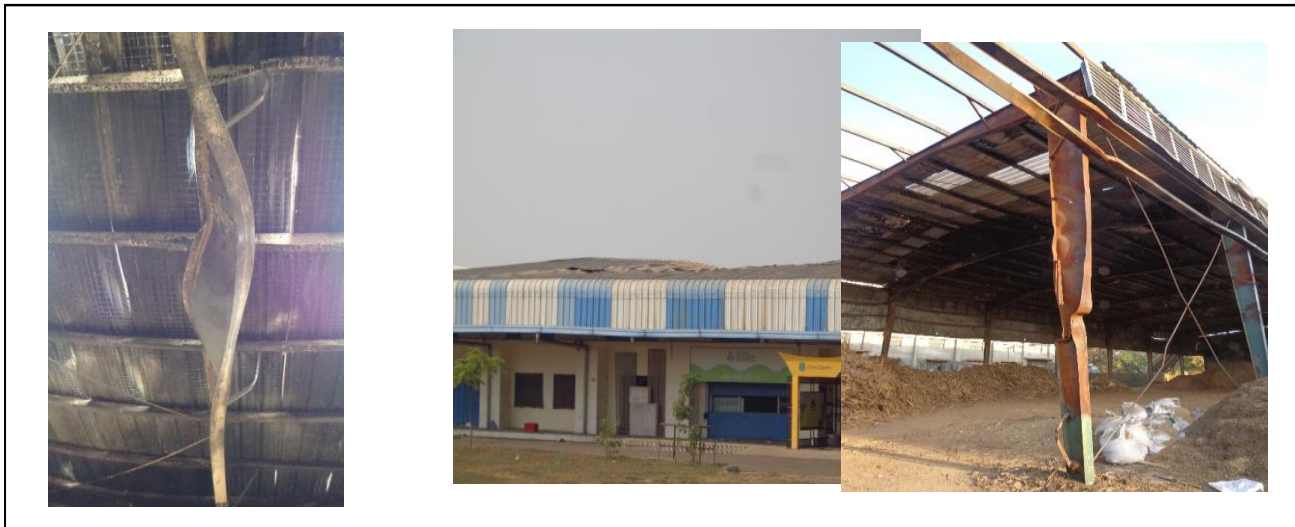
Figure 10 show pictures of few cases of dilapidated due to fire incidents. It may be observed that flange braces, sag rods get snapped easily and cross bracing rods may lose tensile strength, thus compromising the stability of the building. And

cross bracing rods may lose tensile strength. Most of the projects do not specify fire rating of the building. Also due to forbidding cost of fire retardant intumescent paint, only specialized applications use them.

Fig. 10 Building Collapse – Partial and Complete Due to Fire Accidents, Sagging Roof

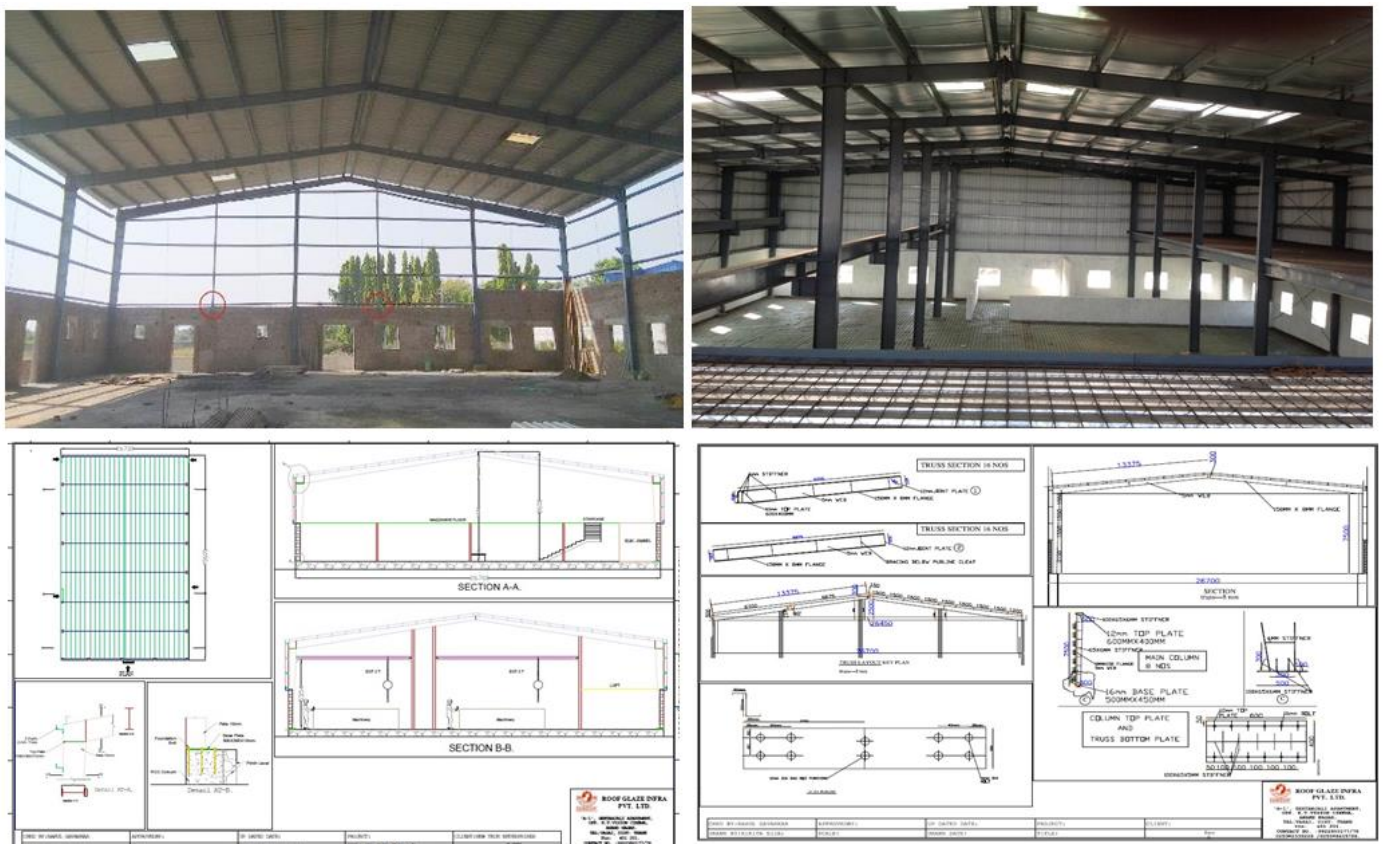
Fig. 11. Case of Impending Failure, project drawings and Final New Building

Figure 11 shows metal bulding which may be termed as impending collapse on left top while right top is picture ew and replace oe. The building is in the palghar clear span of 26m and height of 7.5m.

There wew not even technical documents to assess the requirement and what was erected as PEB

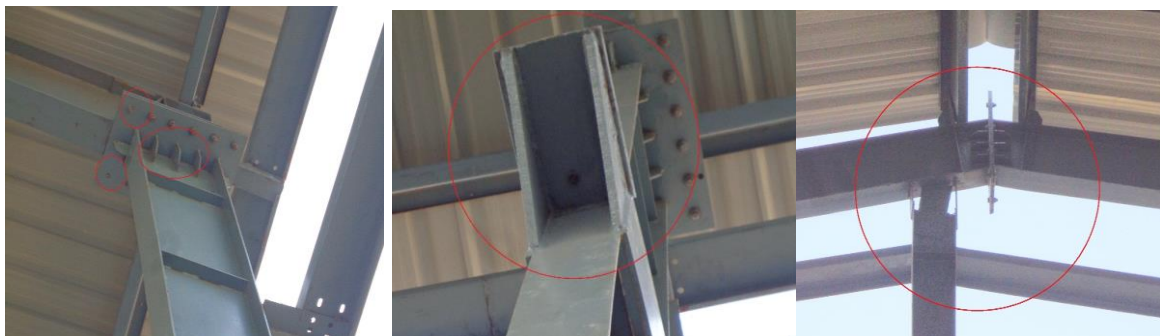
Figure 12 shows poor knee splice where stiffeners were of smaller size, gap in splice plates, bolts of different sizes, crane bracket welded on edge of flanges and endwall column connected to rafter at

endwall column was directly supported on brick wall ad pirlins welded on clear or rafter without lap or sag rods etc.

top by welding scraps. There was no record of strength of material used. This case is a symbol of lack of awareness about structural stability in industrial buildings.

Figure 12 Poor Splice, Crane Bracket Detail and Endwall Column Top Splice with Rafter

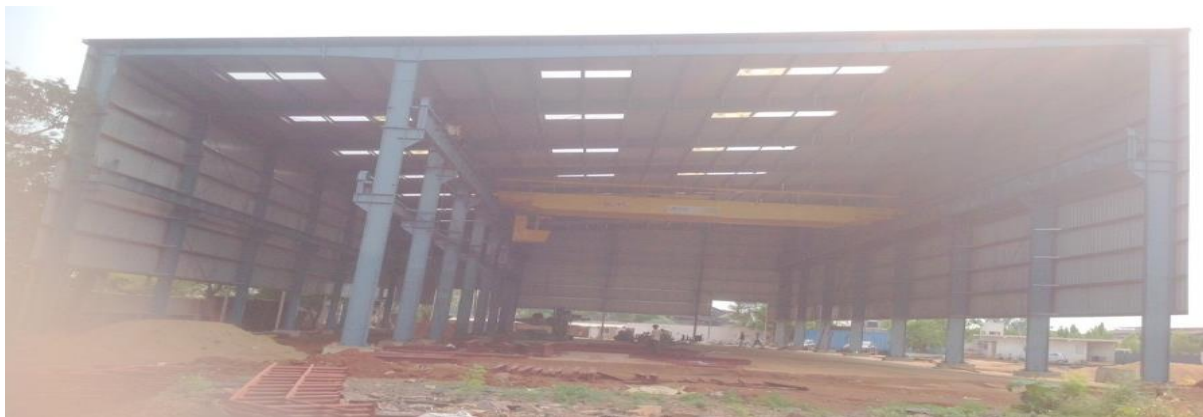
Figure 13 presents a case from Bhilai, Chhatisgarh where the structure was reported vibrations under crane operations of 10MT. The work order showed that the single slope building was supposed to be engineered for future expansion along width with crane load of 20MT in each module. Base plates do not have stiffeners and column did not have bracket

for future crane. Rafter section at knee is less than that of section at centre span of rafter. There were no angle bracing for longitudinal forces of the crane. Documents showed that building was designed for winds loads as closed building and not partial open case.

Fig. 13 Single Sloped Building Scheduled For Expansion – Deemed Failure

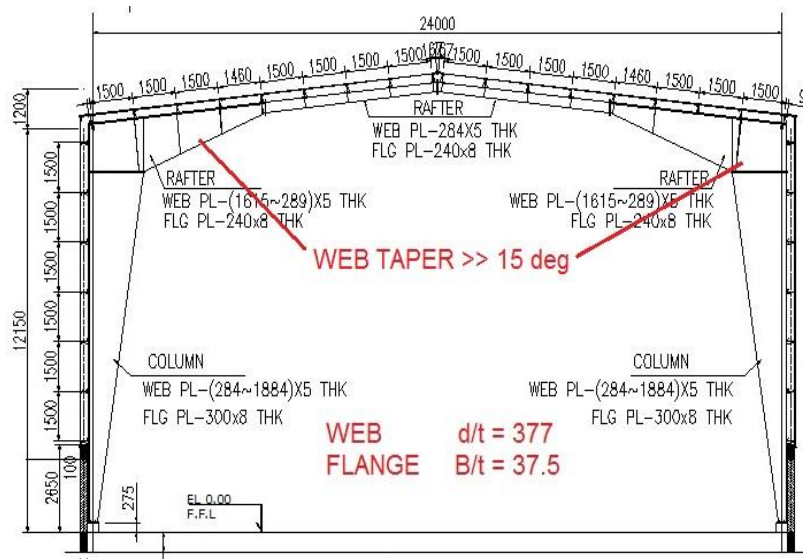
Figure 14 presents a cross section of a frame of 24.0 m width and 12.15m eave height near Bengaluru. Web depth of column was increased from 300 to 1884 mm with thickness only 5mm. Similarly for rafter having web thickness of 5 mm only, web depth reduced from 1615mm to 284 mm, in about 4.5 meter. For column, web depth to thickness ratio was 377 while for rafter it was 323. Similarly flange of 300x8 mm is used with b/t ratio of 37.5^[2,3].

These slenderness ratios are far more than that of codes. For webs, d/t ratio of 180 is adopted as maximum in practice. For flanges b/t ratio of 30 is used in industry as maximum. Also taper angle provider for rafter was more than 15° as recommended by AISC^[2,3].

Figure 14 Frame Cross section showing section sizes with d/t and b/t ratios exceeding limits.

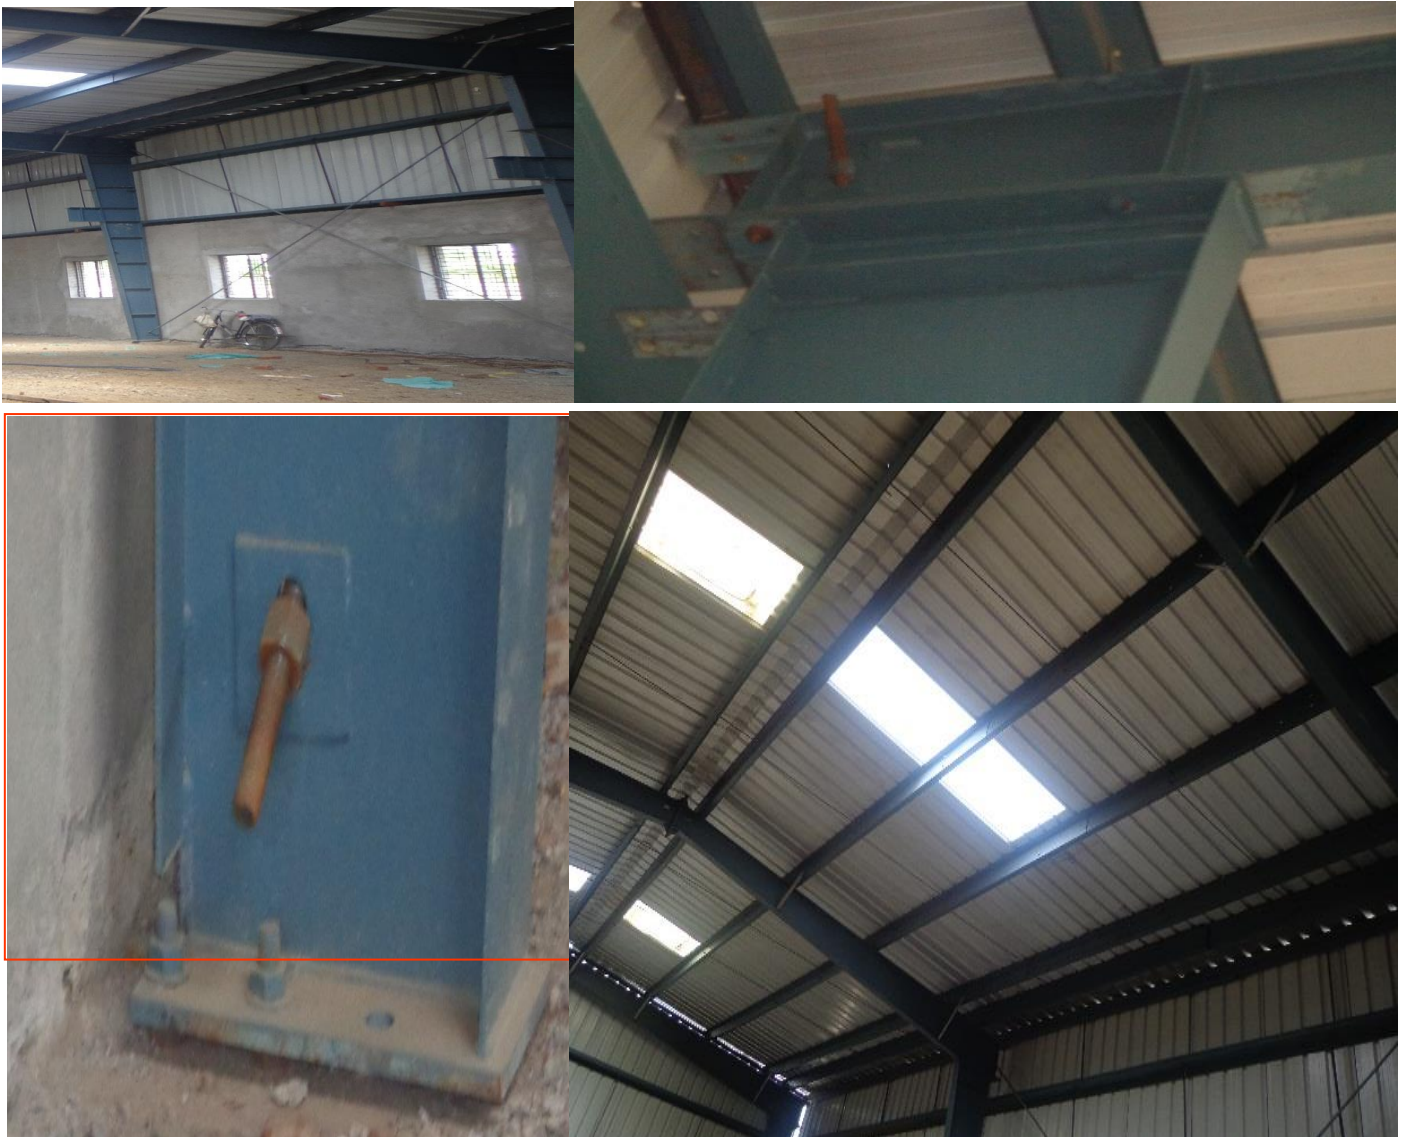
Figure 15 shows the details of a building near wardha of width 12m and height 6m. building specifications were changed after complete engineering of PEB building was over, like shifting of plinth beam inwards and addition of crane beams. However re-engineering of PEB building was not done before execution. Column flange at base plate was cut to accommodate anchor bolt, crane bracket

was added without modifying bracing in walls. Splice plate at knee from rafter did not overlap column splice plate, leaving only two pairs of connection bolts. Purlins supplied and erected were of about 6 meter length, whereas bay spacing was about 8 meters. This led to purlin overlaps falling mid-span with single purlin section over the rafter. Bracing rods were erected without hillside washer.

Fig. 15 Outer Flange Cut, Mismatch in Knee Splice Plate, Wrong Bracing and Midspan Purlin Laps
