HEALTH MONITORING DETERIORATED CONCRETE USING AN CALORIMETRY ANALYSIS

This project investigates the design and performance of M30 grade concrete, focusing on analysing its relations between colour profiles, deterioration and residual strength after a chemical attack using image-based techniques. The study involves casting and curing M30-grade concrete cubes over 28 days for optimal strength. After curing, the cubes were placed in four different chemical solutions: Hydrochloric Acid (HCl), Sodium chloride (NaCl), sulphuric acid (H₂SO₄), and Acetic Acid (CH₃COOH), each at a concentration of 5%. The immersion durations were 7, 14, 28, and 56 days. Following exposure, the samples undergo photography, and the images are analysed using CIE-XYZ colour space. The analysis extracts colour profiles and chromaticity diagrams to quantify the extent of chemical-induced deterioration. The results provide a detailed understanding of how different chemicals impact the structural integrity of M30-grade concrete and offer insights into the material's durability under aggressive environmental conditions. This research enhances the understanding of concrete performance in real world scenarios and con

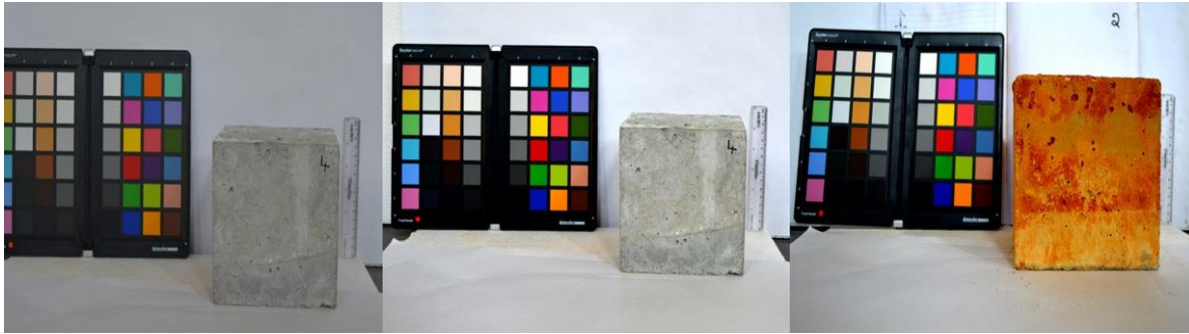
Figure 1. (a) Uncalibrated control sample; (b) calibrated undamaged control sample; (c) calibrated damaged Sample

The colour equilibrium of the was adjusted using a color-checker card. images. This calibration process corrects the colour information in the images, ensuring accuracy for subsequent analysis (see Figure 1). After calibration, the images were organized based on the type of reagent and immersion duration.

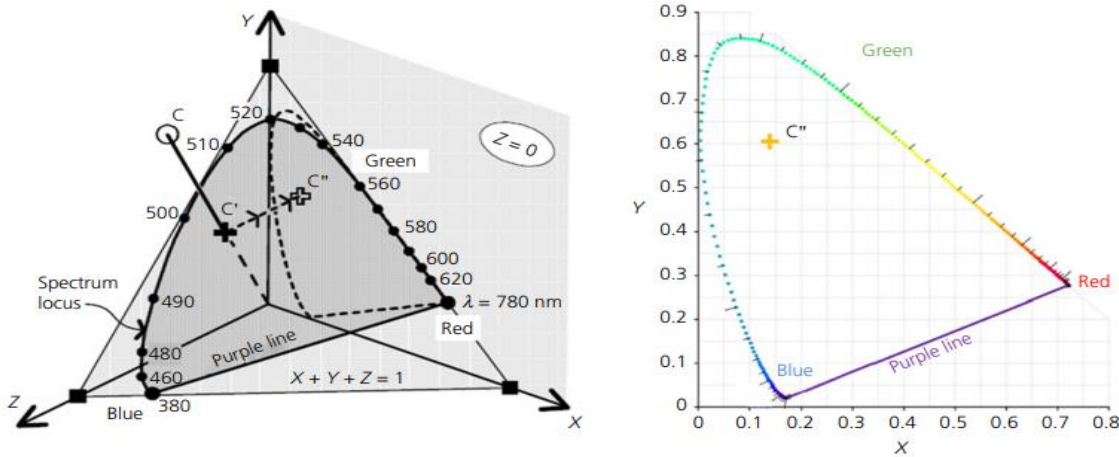
Figure 6. Chromaticity diagram (Wei *et al.*, 2019)

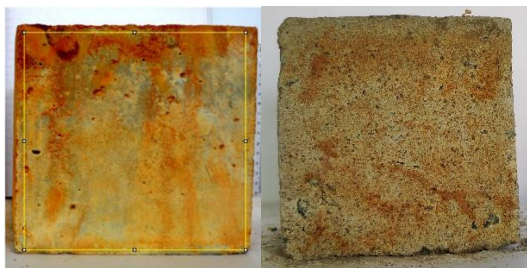
Figure 7. (a) Rectangular region of interest selection; (b) random pixel selection

Finding the pixels that most accurately captured the colour features of the damaged surface was the main goal. In order to do this, many techniques for choosing the ROI (region of interest) were assessed. It was assumed that the chosen pixels within these regions would accurately capture the overall colour information of the damaged area. For this study, both rectangular and random pixel-based ROIs were used, depending on the specific requirements (refer to Figure 7).

Rectangular and polygonal regions of interest (ROIs) encompass a large number of pixels, enabling accurate determination of the mode values from the RGB color histograms. These mode values correspond to the most frequently occurring RGB values within the ROI. In contrast, the random pixel selection method involves fewer pixels, leading to less reliable mode values. Therefore, for random pixel selections, 'The RGB histograms' mean values were utilised in their place. That was discovered. the differences between the mode values derived from the rectangular and polygonal ROIs and the mean values obtained from the random pixel selections were minimal across all images analyzed. As a result, mode values from the RGB histograms of rectangular and/or polygonal ROIs were used for the primary analysis, while mean values from random pixel selections served for validation.

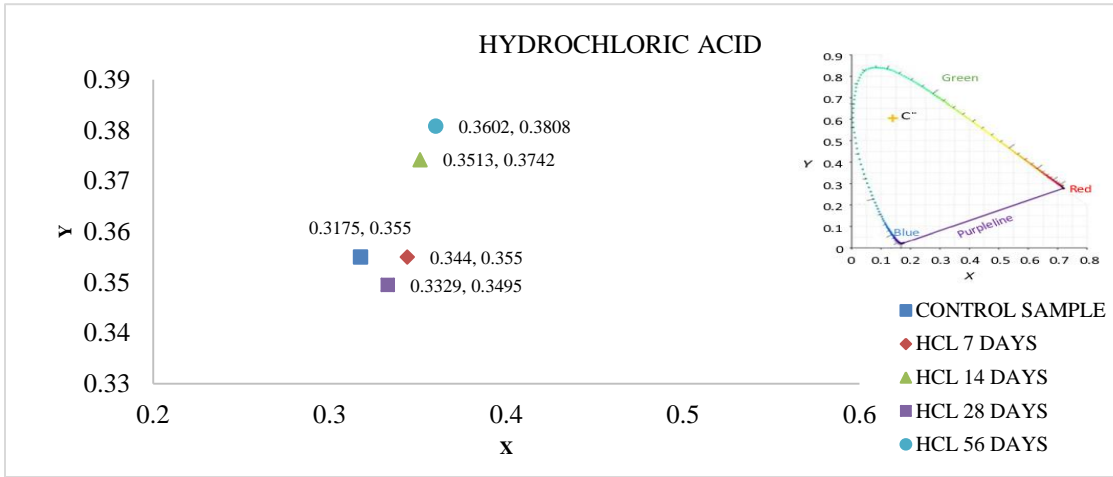
Figure 8: Chromaticity diagrams showing (a) the control sample and the surface deterioration resulting from immersion in a 5% hydrochloric acid (HCl) solution after (b) 7 days, (c) 14 days, (d) 28 days, and (e) 56 days.

During the examination for samples submerged in hydrochloric acid in terms of x and y values, we identified several outliers that deviated significantly from the typical x and y values for that particular immersion duration. These outliers likely indicated localized damage caused by hydrochloric acid rather than reflecting the overall colour of the damaged surface. Consequently, these data points were excluded from further analysis.

Plotting the remaining information points on the chromaticity graph, as shown in Figure 8, showed a clear shift towards red, which was especially apparent when comparing the data points after 14 days of immersion in hydrochloric acid with the control sample. Visual

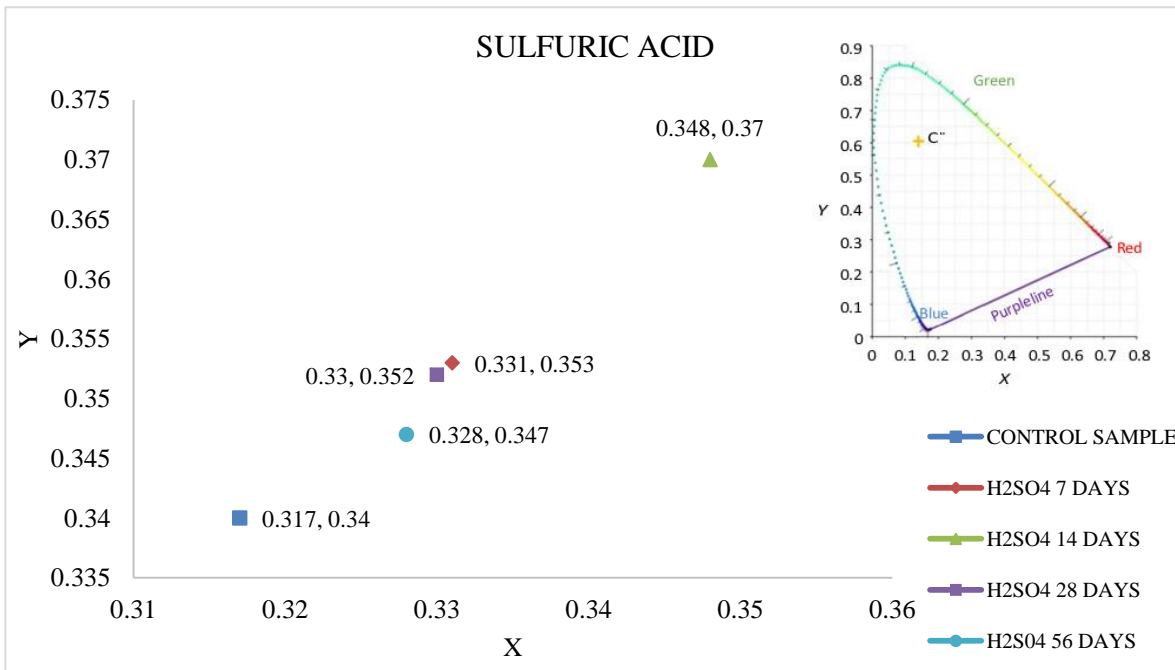
Figure 9: Chromaticity diagrams illustrating (a) the control sample and the surface degradation resulting from immersion in a 5% sulfuric acid (H₂SO₄) solution after (b) 7 days, (c) 14 days, (d) 28 days, and (e) 56 days.

The subsequent analysis adhered to a similar approach. When evaluating data points from samples exposed to sulfuric acid, a notable inconsistency emerged after 14 days of immersion. The colour data, which indicated maximum deterioration, might not always reflect accurate conditions. The surface showing inconsistent values likely provided erroneous colour information, possibly due to sulfuric acid reacting with surface impurities.

After being submerged in sulphuric acid for 14 days, there was a noticeable change in the data points' location from the origin, as seen by a chromaticity graph. As illustrated in Figure 9, there was a discernible trend into the colour white when compared data points from the 56-day soaking period with those from the control sample. Figure 3 displays 3D surfaces plots of the damaged surfaces at several time periods (7, 14, 28, or 56 days), which support this observation. Notably, samples immersed for 28 days displayed considerable surface pop-outs. When these surfaces break down and the formation of white salts, such as ettringite, contributed to the white shift observed in the chromaticity diagram.

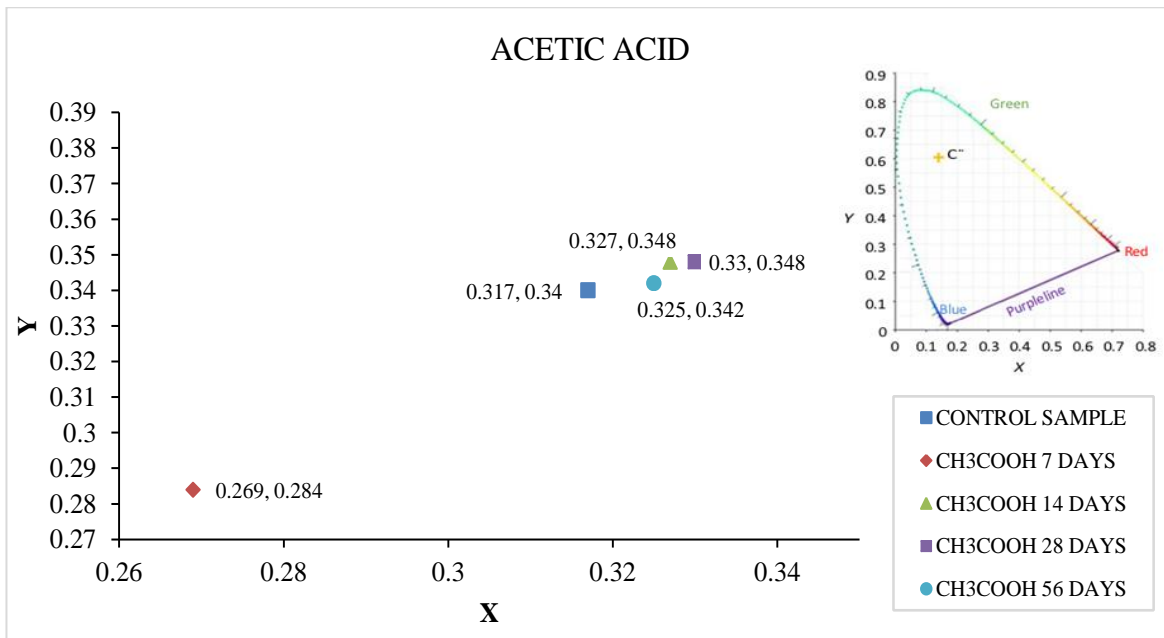
Figure 11: Chromaticity diagrams illustrating (a) the control sample and the deterioration of surfaces following immersion in a 5% acetic acid (CH₃COOH) solution for (b) 7 days, (c) 14 days, (d) 28 days, and (e) 56 days.

The chromaticity graphs for the samples are shown in Figures 10 and 11. immersed in sodium chloride and acetic acid, respectively. The data show minimal variations in colour profiles across different immersion periods, suggesting limited changes in surface colour over time for these reagents. Consequently, any localized colour changes should be regarded as specific points of interest, as the

For samples immersed in acetic acid the chromaticity graph barely slightly shifts towards white at the 28 and 56-day data points. Specifically, the 56-day data point is positioned near the red end of the spectrum, with only a slight shift towards white compared to the 7-day immersion point. The colour change profiles are depicted in Figure 5. To further understand the variations in colour profiles observed on deteriorated surfaces, additional analysis was performed to assess the effects of each deteriorating agent.

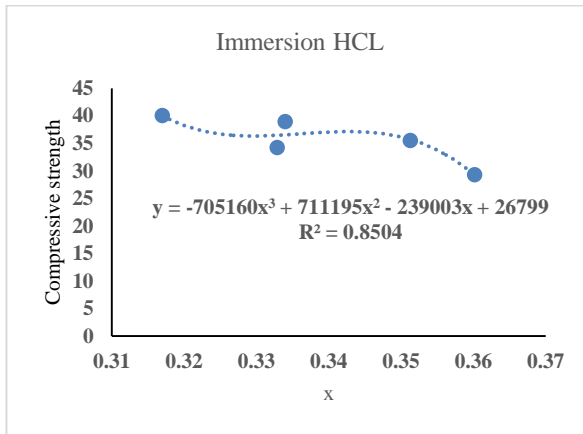
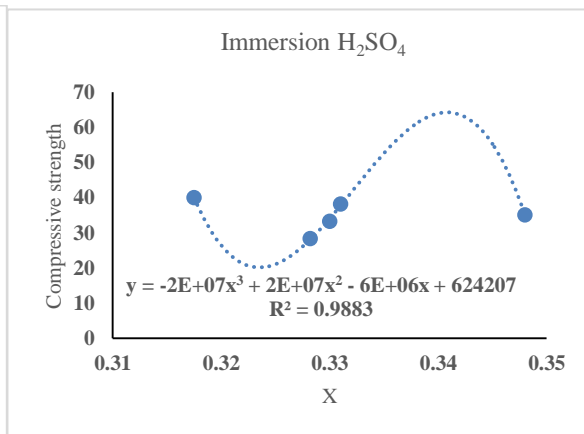
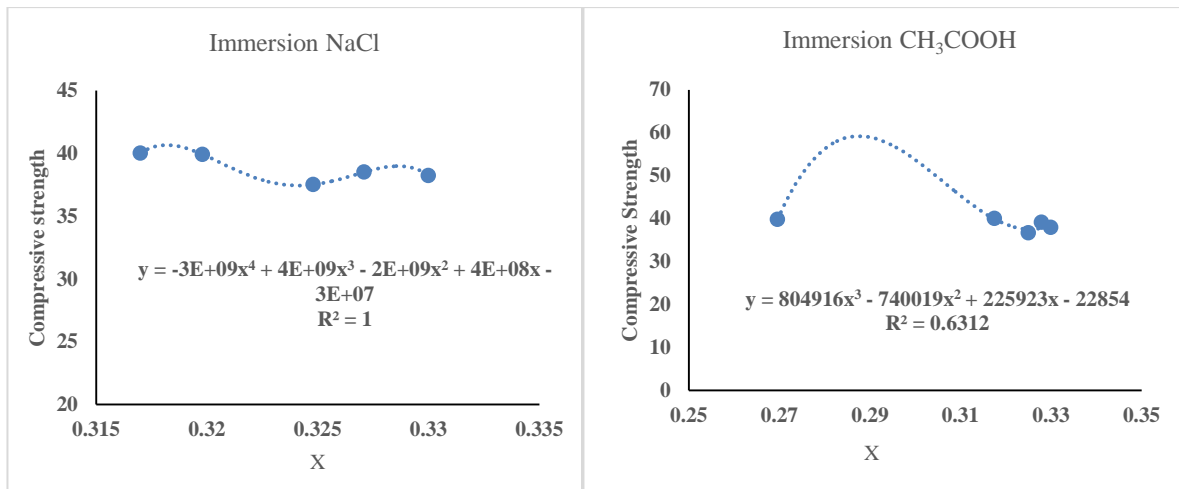
Figure 12. Polynomial curve fitting was employed to establish a correlation between chromaticity coordinates (x) and the corresponding compressive strengths of samples immersed in various reagents at a 5% concentration for 7, 14, 28, and 56 days.

Figure: 12 presents the polynomial relationships relationship with the colour 'x' values with the associated compressive strength values of the samples over different immersion periods (7, 14, 28, and 56 days). The analysis indicates that while the correlations between chromaticity 'x' values and compressive strength show similar trends across various immersion conditions, the slope of these relationships differs based on the reactivity of the reagent used.
