# Experimental and FEM Analysis (ANSYS) of Conventional and BFRP Composite Beam

<sup>1</sup>Sourabh M. Kadam, <sup>2</sup>Dr.Chetan Patil

<sup>1</sup>Student Sanjay Ghodawat University Kolhapur, India.

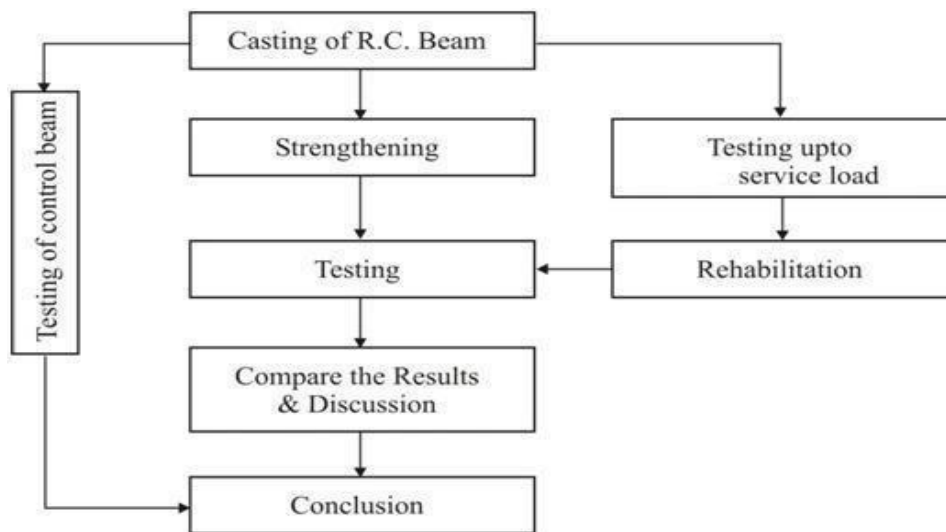
Figure 1 Methodology of Project work

Following Figure No. 1 shows the methodology adopted for the proposed work.

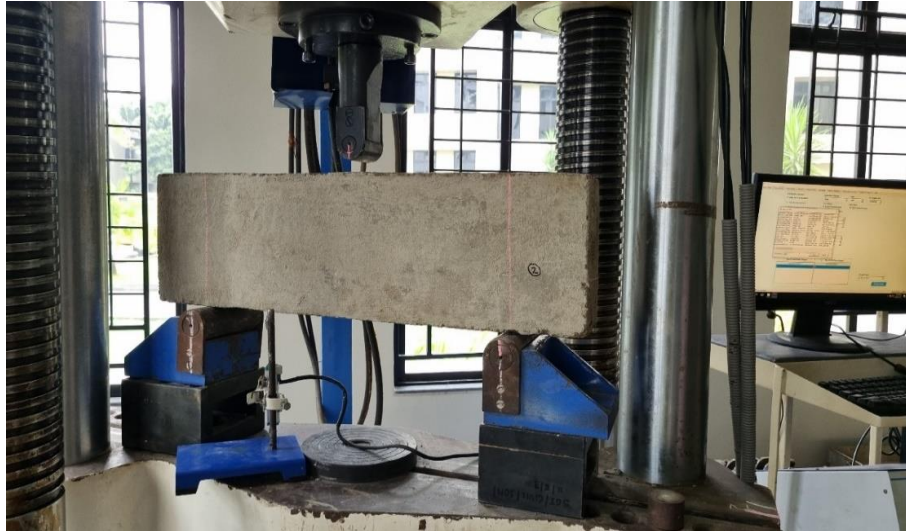
Figure 2 Testing of RC beam section for three-point loading in UTM

Testing a reinforced concrete (RC) beam section under three-point loading involves placing the beam on a Universal Testing Machine (UTM) and applying a load at a single central point while supporting the beam at both ends. This test helps determine the load carrying capacity and behavior of the beam under load. The testing of a reinforced concrete (RC) beam under three-point loading is conducted using a Universal Testing Machine (UTM) with a capacity of 1200 kN. Here is a detailed procedure for conducting this test:

Place the beam on the supports of the UTM. The supports should be properly aligned and spaced to create the required span length for the test. Measure and set the span length between the supports, typically to a standard length such as 500 mm.

Gradually apply the load at a constant rate through the loading head. The load should be applied smoothly to avoid any sudden shocks. Continuously monitor the load and deflection readings. Use a digital indicator or dial gauge placed at the bottom center of the beam to measure deflection accurately.

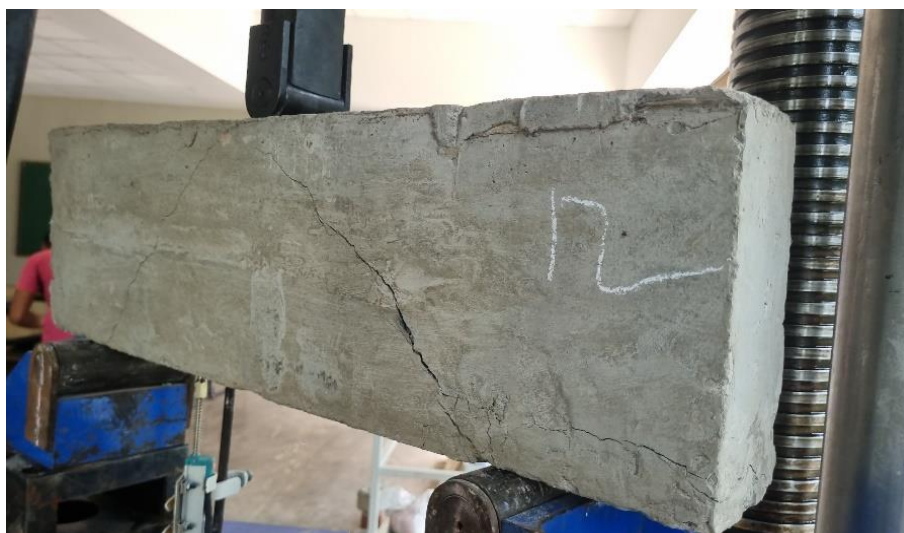
c) Beam B12

Figure Error! No text of specified style in document. The crack development at ultimate load for RC beams

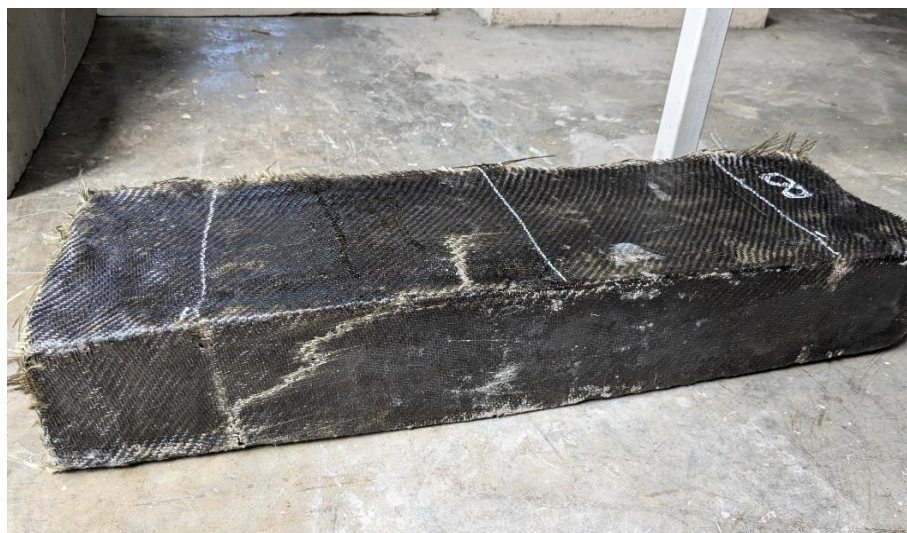
A reinforced concrete (RC) beam with Basalt Fiber Reinforced Polymer (BFRP) fabric on two sides and the bottom face.

Figure.1 The RC Beam with BFRP fabric @ two sides and bottom face

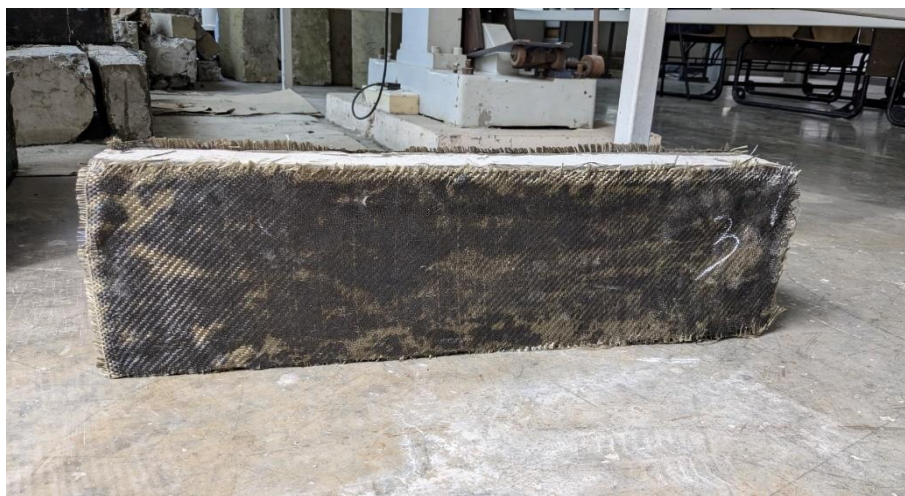
b) Beam B3

A reinforced concrete (RC) beam with Basalt Fiber Reinforced Polymer (BFRP) fabric on two sides face

Figure 7 The RC Beam with BFRP fabric @ two sides face only

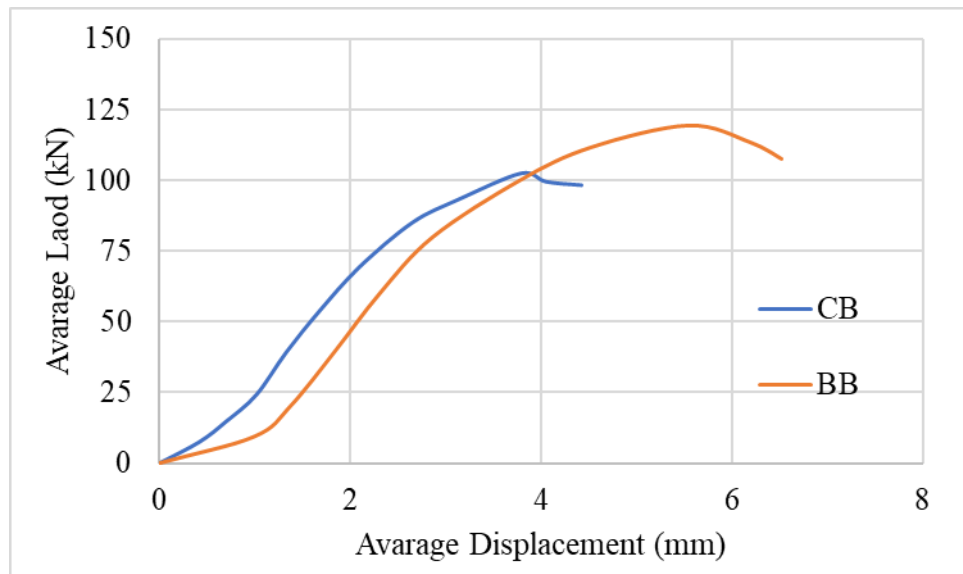
Figure 10 The load deflection curve for control beam (CB) & RC Beams with BFRP fabric @ bottom face (BB)

Figure 10 illustrates the load-deflection response of the control beam (CB) compared to an RC beam retrofitted with BFRP fabric on the bottom face only (BB). Both beams demonstrate a linear relationship between load and displacement during the initial loading phase, reflecting elastic behavior. The retrofitted beam (BB) appears to have a slightly lower initial stiffness compared to the control beam, as indicated by the more gradual slope of the curve in the elastic region. As the load increases, both beams exhibit nonlinear behavior, which corresponds to the initiation of cracking and other inelastic deformations. The retrofitted beam (BB) starts showing signs of nonlinearity at a slightly higher load than the control beam, indicating that the BFRP fabric on the bottom face effectively enhances the beam's resistance to cracking and initial damage.
