Exploring the current condition of footpaths: a case of Pune

Abstract - Footpaths are one of the essential infrastructures for mobility but nowadays they are in a dilapidated condition. Walking on footpaths tests our patience and tolerance. It is a zero investment exercise associated with multiple health benefits. The easiest way to remain fit and active is by walking which is an environment friendly and sustainable mode of transport. Pedestrians have to put their lives in danger while walking on footpaths. If footpaths are not properly designed then people do not feel like using them and so they remain underutilized for the purpose they are designed but are encroached by other activities. It is seen that footpaths are given the least priority in the design of roads. People do not feel safe and comfortable while using them. For pedestrians the footpath has gone from bad to worse. There are a lot of obstructions for pedestrians to walk on the footpaths. These obstructions can be due to hawkers', encroachments, parking of vehicles, uneven surface and many more. This research paper gives the current condition of footpaths and the barriers to walking on them in three different places

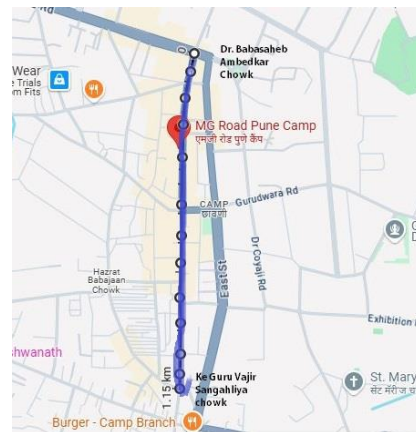
Fig 2: Footpath stretch of the study area on Mahatma Gandhi road

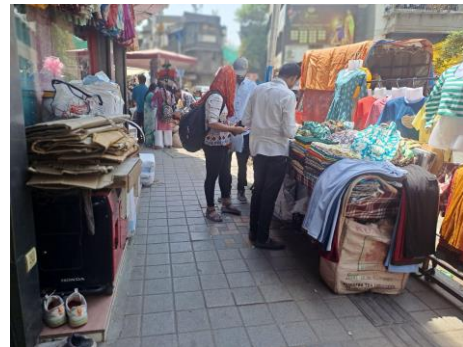
Under the encroachment parameter, it was observed that a significant portion of the footpath is occupied by illegal hawkers, vendors and shopkeepers, leaving minimal or no space for pedestrian movement. The absence of designated vending zones has led to unregulated occupation of footpaths, where vendors set up stalls and attract crowds of buyers, further obstructing the pathway. In several instances, eateries have extended their operations onto the footpaths by placing cooking units or seating arrangements, resulting in both obstruction and unhygienic conditions.

Pedestrians are often forced to step onto the main road, making them vulnerable to accidents thus reducing the overall safety. Additionally, some shopkeepers have encroached upon the footpath by displaying goods and semi-permanent structures outside their stores, especially on MG Road and Laxmi Road, where the extent of encroachment is significantly higher compared to FC Road. Although encroachment by eateries was found to be relatively low across all three roads, the cumulative impact of hawkers and extended shop fronts poses a major challenge to footpath usability and urban walkability.

Fig 4: Hawkers on Laxmi Road. Source - Author

To restore footpaths for the purpose they are constructed some actions need to be taken. Illegal vendors must be punished and an exorbitant fine must be charged to them. *Regular maintenance, strong policy enforcement and strategic planning are essential* (Bohara & Tiwari, 2022). Encroachments must be removed, vendors to be given a designated area and inclusive design considerations to be implemented for elderly individuals, children and persons with disabilities alike. Just by providing proper facilities like creating space for pedestrians does not end the matter but there must be proper maintenance and inspection of the amenities which is the responsibility of the authorities. The concerned authorities should now give heed to the pedestrians and their very own space to walk. *The types of barriers are different so accordingly strategies to remove them should be planned based on their favourable outcomes* (Advani, Paridab, & Parida, 2016).

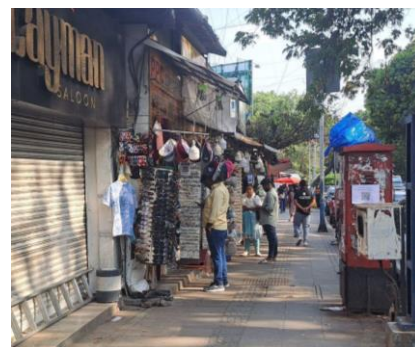
Fig 5: Extended shops on F.C road. Source - Author

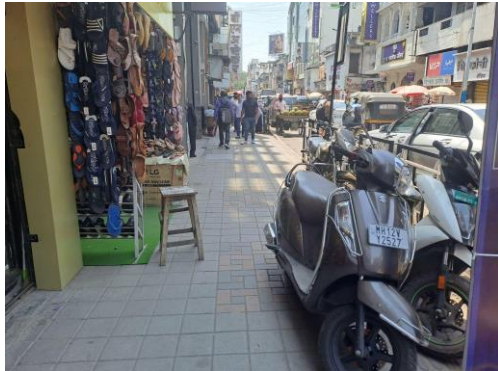
Under the parking parameter, it was seen that footpaths are frequently misused for parking. At some places on all 3 streets it was seen that the parked two wheelers often occupy some portion of the footpath, leaving insufficient room for pedestrians and compelling them to walk on the road, which forces them to come in the way of the fast moving traffic thereby contributing to traffic congestion. In many cases, even when four-wheelers are parked along the roadside, a portion of the vehicle extends onto the footpath, significantly reducing the usable walking space. Improper and haphazard parking practices not only obstruct pedestrian movement but also create a hostile and unsafe environment.

Fig 6 : Parking of two wheelers on footpath on Laxmi road. Source- Author

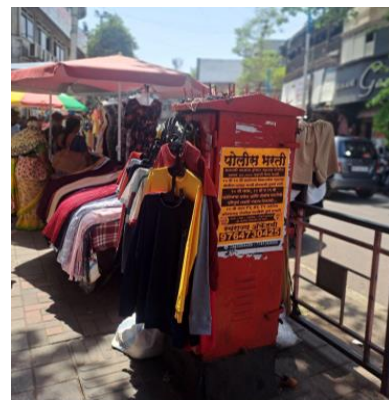
Fig 7 : Electricity boxes used for display purpose Laxmi road. Source: Author

In contrast, MG Road and Laxmi Road lack these features. Their infrastructure is either outdated or poorly maintained, resulting in a compromised pedestrian experience. Moreover, manhole covers at some places on all three roads are often misaligned, creating trip hazards and electricity boxes were used to display stuff by the hawkers on MG road and Laxmi road.

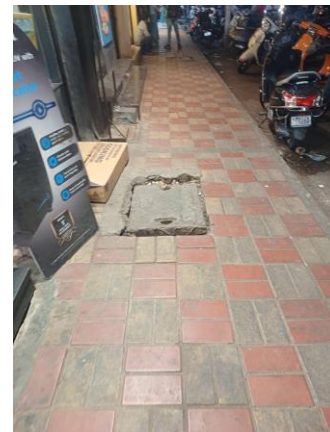
Fig 8: Sewer cover not in line with the footpath level on MG road. Source: Author

This analysis underscores the need for improved maintenance and people-centric planning free from obstructions, encroachments, etc. to make footpaths more inclusive, safe and functional for the purpose they are built. The footpaths must not lose their primary purpose and character.

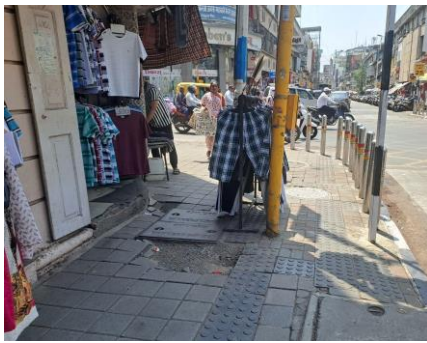
Under the physical parameter it was seen that in many sections, tiles and paver blocks were found to be damaged, missing or unevenly laid making walking uncomfortable and hazardous particularly for senior citizens, children and persons with disabilities. A notable highlight of FC Road is the presence of supportive infrastructure that enhances both utility and aesthetics. In addition to a well-defined footpath, there is a dedicated cycling track and uninterrupted tactile paving, promoting multimodal and inclusive use. Public toilets are also available on FC Road, while such amenities are lacking on MG Road and Laxmi Road. Further, a distinct belt of planters and strategically placed street furniture contributed to the street’s visual appeal and walkability.

Fig 9: Missing tiles on footpath on Laxmi road.
Source – Author

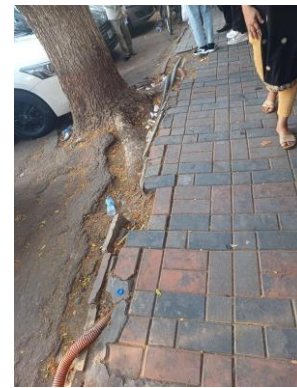
Fig 11: Edges of footpaths on MG road. Source - Author

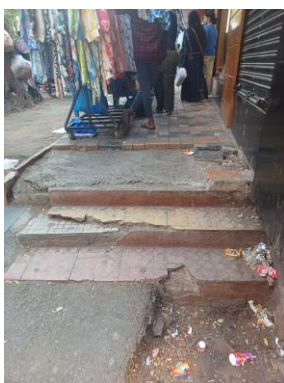
Universal accessibility is a crucial aspect of footpaths. This parameter is partially absent on the footpaths of MG road and Laxmi road. Only on FC road the footpaths width is able to accommodate a wheelchair user. There were tactile pavers on footpaths of Laxmi road and FC road only but they were occupied by hawkers on some stretches. Ramp provision is completely absent on MG Road, inconsistently implemented on Laxmi Road and comprehensively integrated along FC Road, making the latter the most accessible of the three.

Moreover, steps leading to the footpaths on MG road were often lacking proper tiling and accessible ramps, posing serious challenges to universal accessibility.

Fig 10: No ramps provided on footpath at MG road.
Source - Author
