Identification of Accident Black Spots on NH-65 (Chaudhriwas, Hisar to Hisar City)

This paper deals with the study and to analyze the traffic safety situations in the section from Chaudhriwas, Hisar to Hisar City on NH-65(new NH-52) in the state of Haryana(India) and to identify countermeasures for the stretch so that the total harm caused by the road crashes can be reduced to some extent in future. The stretch of 19.5 kms is taken for study. In this paper, the identification of road accidents and its causes, variations with respect to yearly, monthly, hourly, user type, vehicle, age, seasonal and also the number of black spots by further giving the suggestions and conclusions to reduce the road crashes and to make safer for road users.

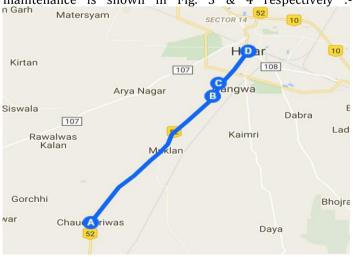
Fig.-2: Black Spot Locations

Location	No. of Accidents
Chaudhriwas Village, Hisar (A)	17
Gangwa Village, Hisar (B)	25
Azad Nagar, Hisar (C)	21
Hisar City (D)	15
Total	78

Black Spot Locations are shown in the Fig.-2 and stretch condition including formations of ruts, pot holes and poor maintenance is shown in Fig. 3 & 4 respectively:

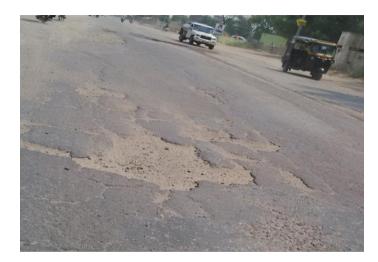
Fig.-3: Formation of ruts, cracks and pot holes nearby Gangwa Village, Hisar.

- 8) Proper lighting in the village areas like Gangwa and Chaudhriwas needs to be installed for the efficient movement of heavy traffic on highway.
- 9) Filling of cracks, patch work need to be done on the complete stretch as there is heavy traffic flow takes place.
