Identification of Accident Black Spots on NH-65 (Barwala to Surewala Mod, Barwala Road)

This paper deals with the study and to analyze the traffic safety situations in the section from Barwala to Surewala Mod, Barwala Road on NH-65 in the state of Haryana, India and to identify countermeasures for the stretch so that the total harm caused by the road crashes can be reduced to some extent in future. The stretch of 16 kms is taken for study. In this paper, I have identified the road accidents and its causes, variations with respect to yearly, monthly, hourly, user type, vehicle, age, seasonal and also I have identified the black spots by further giving the suggestions and conclusions to reduce the road crashes and to make safer for road users.

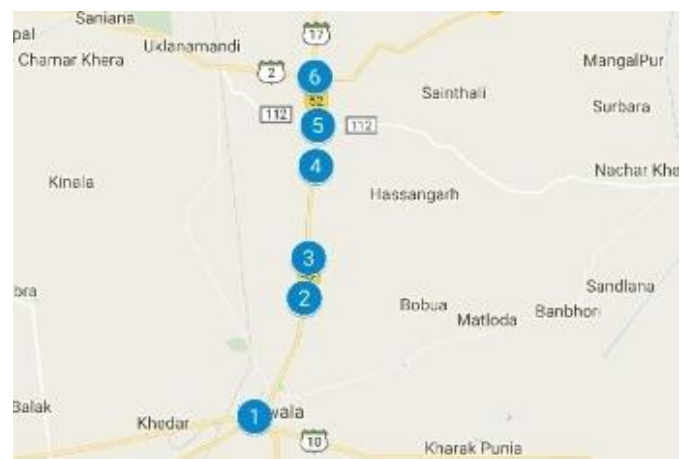
Fig. -2: Black Spot Locations

Location	No. of Accidents
Old Bus Stand, Barwala (1)	17
Dhani Prem Nagar, Barwala (2)	16
Ghaibipur, Barwala (3)	17
Kallar Bhaini, Barwala (4)	14
Litani Mod Village, Parbhuwala Road, Barwala (5)	14
Surewala Mod, Barwala (6)	9
Total	87

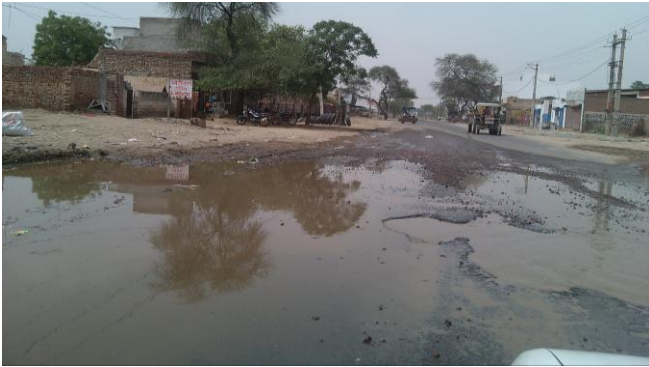
Fig. -3: Formation of ruts, cracks and pot holes and poor drainage system nearby Dhani Prem Nagar, Barwala Road.

- i) Filling of cracks, patch work need to be done on the complete stretch as there is heavy traffic flow takes place.
- j) Proper maintenance of median, pavement markings, traffic signs & symbols should takes place.

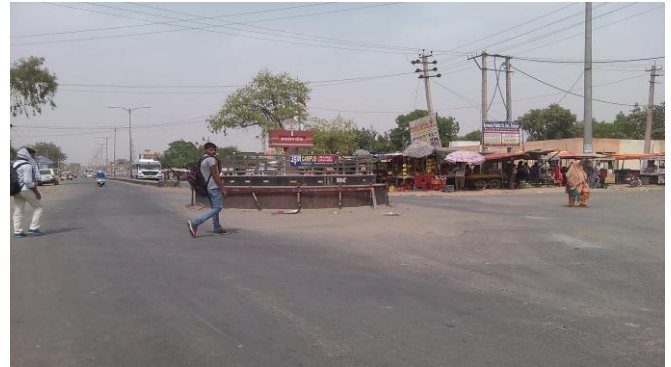
Fig. -7: No pavement markings for vehicles and pedestrians with unprotected 4-leg intersection. Delineators are in poor condition nearby Agrasen Chowk, Barwala Road.

- a) There is a need to maintain the pavement marking in the selected stretch from Barwala to Surewala Mod, Barwala Road.
- b) Speed breakers/Rumble Strips need to be constructed up to the approach road near Old Bus Stand, Barwala, Agrasen Chowk and at every road links of villages.

- c) Inadequate hoardings on the shoulders including advertisements which further results in lack of concentration while driving by driver.
- d) Pedestrian crossing required for the pedestrians to move freely on the road near Agrasen Chowk and Surewala Chowk.

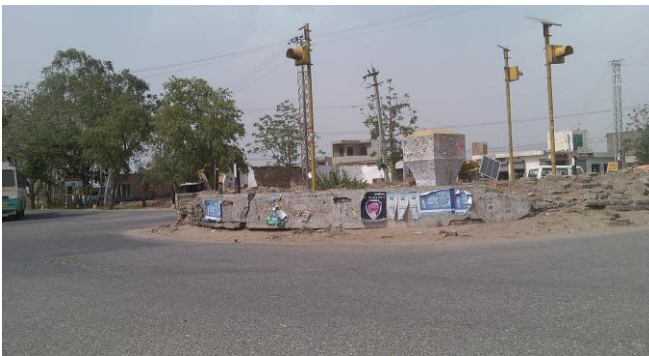
Fig. -4: Poor condition traffic lights, no pavement markings, bad condition of rotary island at Surewala Chowk, Barwala Road.

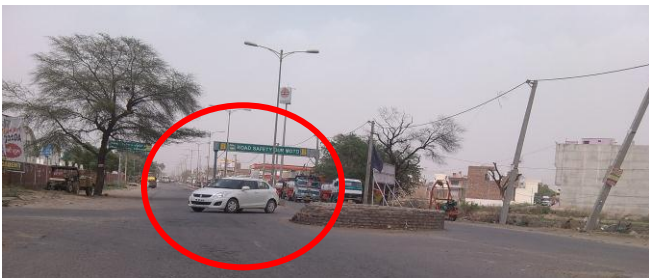
Fig. -5: Wrong crossing of vehicles around the rotary due to non-existence of traffic lights, traffic signs & symbols nearby Old bus stand, Barwala.

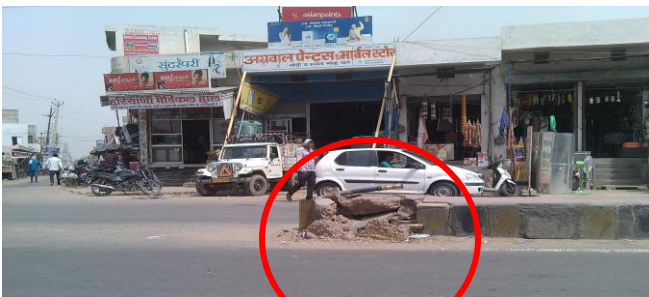
Fig. -6: Poor condition of delineators, reflectors and poor maintenance of traffic signs and symbols nearby Old bus stand, Barwala.
