# Structural Audit of 30 Years Old Building with Structural Strengthening

Aniket Raut<sup>1</sup>, N.H. Pitale<sup>2</sup>, Dr. Dilip P. Mase<sup>3</sup>

<sup>1</sup>Post-Graduate student, Dept. of Civil Engineering, G.H. Rasoni College of Engineering, Nagpur, India

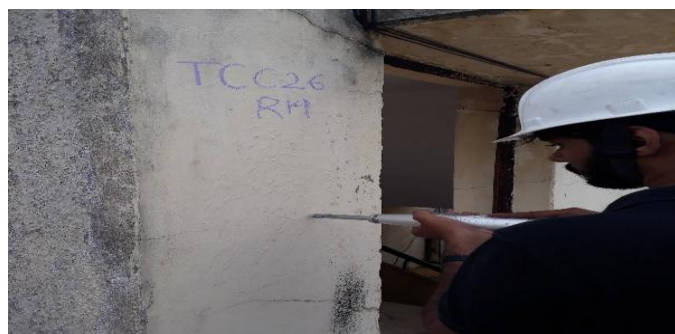
**Fig -1:** Rebound Hammer Test

Since 1940, Rebound hammer test is the most common method used for checking the strength of concrete. In 1948, Ernst Schmidt a Swiss Engineer developed a device for testing concrete, primarily based upon rebound principle when a hammer strikes concrete. There is a metallic rod in

Rebound hammer to which spring is attached. When the body of the instrument is pressed strongly and steadily against the concrete surface, the combination of gravity and spring force, propel the hammer and the rebound distance is expressed as rebound number, which is measured on a scale by slide indicator. The extent of such rebound is an indication of the hardness of concrete. The rebound distance is the percentage of the initial extension of spring and therefore the rebound is taken to be related to the compressive strength of the concrete. For taking a measurement, keep the instrument perpendicular to the test surface. The test thus can be conducted horizontally on vertical surfaces and vertically upwards or downwards on horizontal surfaces. IS 13311 part II 1992 gives a standard test method for Rebound Hammer Test.

The Rebound Hammer Test is used to determine the uniformity of the concrete, quality of concrete in relation to standard requirements, the compressive strength of concrete. IS 13311 part II 1992 gives a standard test method for Rebound Hammer Test.

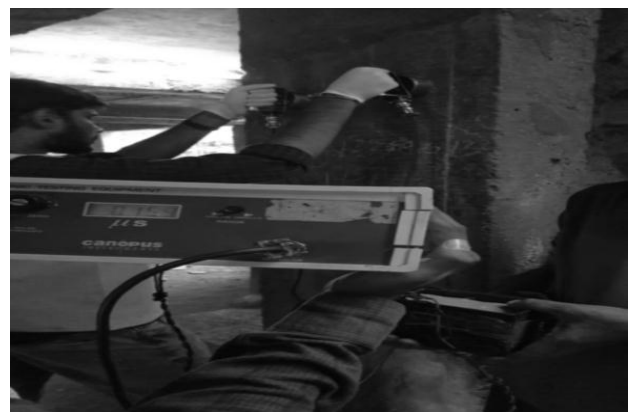
**Fig -2:** Ultrasonic Pulse Velocity Test

The strength of concrete in ultrasonic pulse velocity test is assessed by measuring the velocity of an ultrasonic pulse passing through it. The ultrasonic testing method is based on the use of equipment composed of transducers are placed on

the smooth concrete surface which produce and receive the ultrasonic wave. The time taken by pulse to travel from the transmitting to receiving transducers is measured by a timing circuit. A surface are applied with coupling medium such as petroleum jelly, grease to have good coupling. A better quality of concrete is indicated by higher velocity while if the surface is not uniform and consist of cracks it is indicated by lower velocity.

The pulse velocity in concrete will be represented in Km/sec or M/s. IS 13311 (Part I) 1992 gives a standard test method for Ultrasonic Pulse Velocity Test.

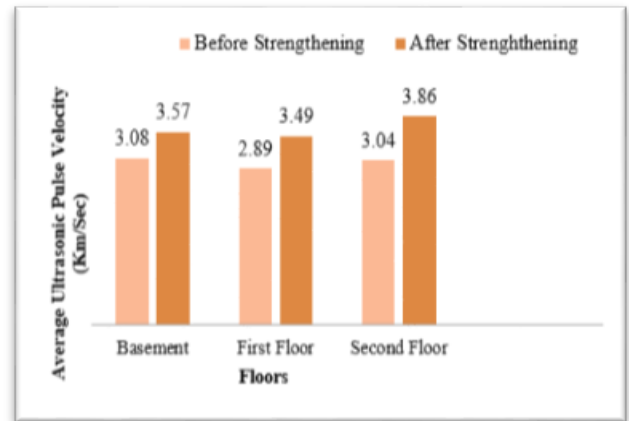
Chart -2: Comparison of Ultrasonic Pulse Velocity Test Results

Sr. No.	Description	No. of Points	Ultrasonic Pulse velocity Test (Km/Sec)		
			Max.	Min.	Average
BASEMENT					
1.	Before Repair	112	3.66	2.51	3.08
	After Repair	82	4.12	3.03	3.57
FIRST FLOOR

2	Before Repair	80	3.24	2.55	2.89
	After Repair	58	4.05	2.93	3.49
SECOND FLOOR					
3.	Before Repair	16	3.25	2.84	3.04
	After Repair	8	4.10	3.62	3.86

As per detailed systematic inspection while conducting Structural Auditing of 30 years old building with Visual Inspection, Schmidt's Hammer Test, Ultra Pulse Velocity Test, before strengthening and after strengthening, It is observed that It is observed that the Ultrasonic Pulse Velocity Test results with direct, indirect and semi direct method found that maximum readings are between 2.51 Km/Sec to 3.66 Km/Sec (Before Strengthening) & 2.93 Km/Sec to 4.10 Km/Sec (After Strengthening) (Refer to IS 13311(Part I):1992).

According to the Visual Observation and Non Destructive Test on existing structure before strengthening and after strengthening, it is observed that the desired strength which is expected is still not achieved by the structure so it is recommended to do RCC jacketing to few columns which are found weak. As per given specifications repairs and retrofitting should be done, to maintain the building in Good condition
