REJECTION ANALYSIS IN FUEL EQUIPMENT

To carry out this project, we took the help of M/s Jay Engineering Works located in Ambattur, Chennai. Using Pareto analysis, the defects with highest percentage of rejections were found. The advance housing is an integral part of the fuel injectors used in the diesel engines. The main function of the AA Housing is to pressurize the fuel before it enters the combustion chamber for the burning of fuel to take place. The raw materials for the manufacture of an AA housing are provided by Delphi TVS. The manufacturing of an AA housing has 20 processes which is done machines like CNC (computer numerical control) and VMC (vertical milling center). The operations like facing, turning, boring and drilling are done in CNC machines and slotting, tapping are done in VMC machines.

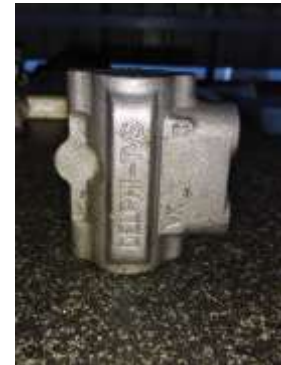
Fig-2: Raw material

The raw materials of an AA housing are provided by Delphi TVS. The material of this housing are made of cast iron. The weight of the raw material usually decreases as the number of operations performed on it increases thus the weight of the advance housing will be inversely proportional to the total number of operations being performed in it. The length of the raw material is 79mm and it must be faced to a length of 76.6 ± 0.2 mm which is the usual ideal length of the housing. The extra 2.4mm on the raw material is provided so as to compensate for any type of mishandling of the material or to overcome the material loss which may take place during a sudden fall or a breaking of the edges.

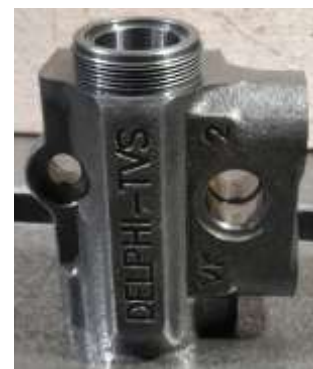
Fig-3: Finished product(front view)

The completely finished appearance of the Advance housing with all the operations is shown above. There are two tapping processes which takes place, one is the M5 tapping and the other is the M14 tapping. The M5 tapping uses the normal carbide tools whereas the M14 tapping uses the carbon tool whose appearance is similar to a gold flake. There are a total of two diameters which are considered main, one hole has a diameter of 10.8mm and the other hole has a diameter of 7.5mm. The centre distance between the two holes is 42.8mm.

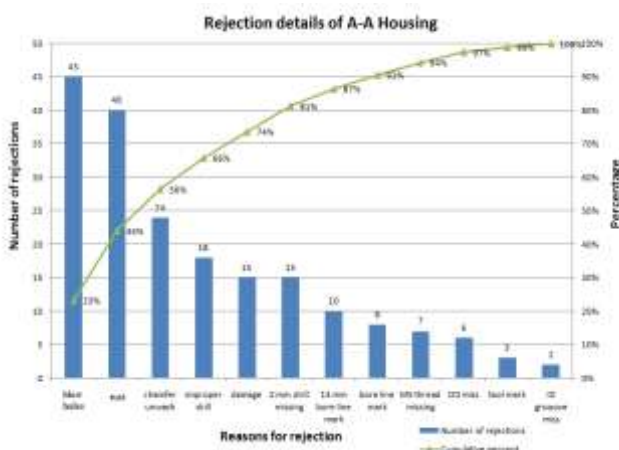
Fig-5: Reasons of rejection

Table-1: Number of rejections occurred(as per the above figure)

REASONS FOR REJECTION	NUMBER OF REJECTIONS
Blow holes	45
Rust	40
Chamfer unwash	24
Improper drills	18
Damages	15
2mm drill missing	15
Bore line mark	8
M5 thread missing	7
OD miss	6
Tool mark	3
ID groove miss	2
Thread damage	10

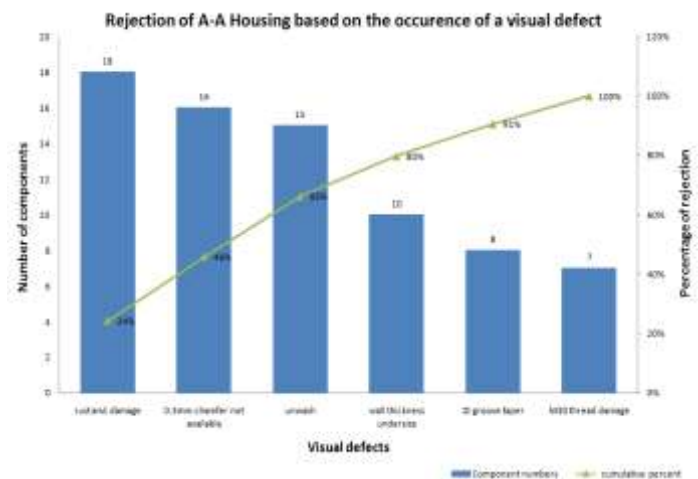
Fig-6: Occurrence of visual defects

Table-2: Rejections due to visual defects(as per above figure)

REASONS FOR REJECTION	NUMBER OF REJECTIONS
Rust and damage	18
Chamfer not available	16
Unwash	15
Wall thickness undersize	10
ID groove taper	8
Thread damage	7

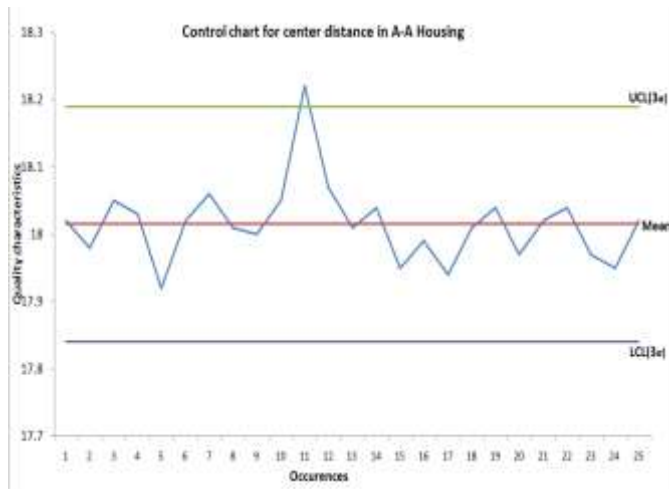
Fig-7: Control chart for center distance in AA housing

The readings were taken on a daily basis for a month and were recorded in the form of a control chart. The average of the samples is 18.015mm which is taken as the centre line for plotting the chart. The UCL is 18.19mm and the LCL is obtained as 17.841mm. Out of 25 readings recorded, one of the measurements for the center distance was found to be lying beyond the UCL of 18.19mm which was observed on the 11th day. This is the pattern that signifies an out of control point special cause of variation.

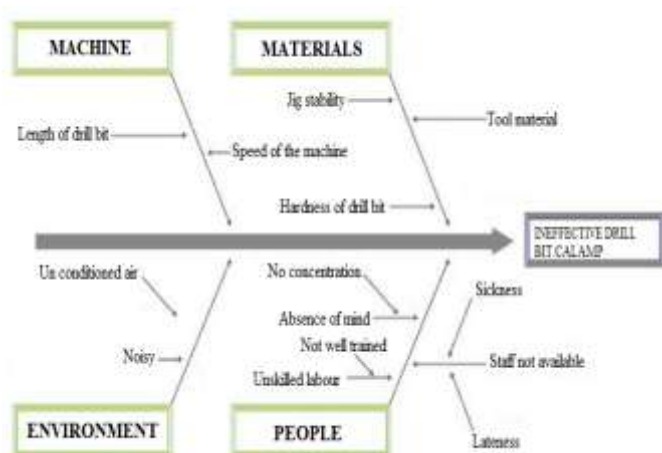
Fig-8: Fishbone diagram for ineffective drill bit clamp

The following listed causes are the governing factors that define the state of the clamping. To control this, either the entire sub causes must be kept under control or the main causes must be eliminated so that it also removes the sub causes which lie within these major causes. Once these major causes are controlled or eliminated the sub causes are under control automatically.

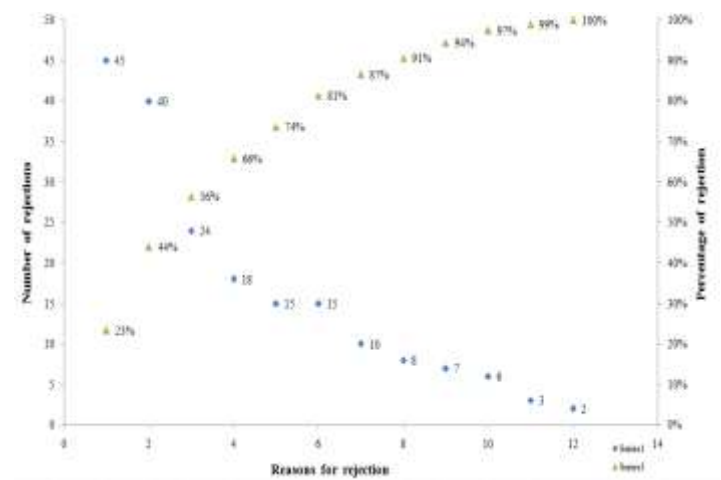
Fig-10: Scatter diagram

The scatter diagram graphs pairs of numerical data, with one variable on each axis, to look for a relationship between them. If the variables are correlated, the points

will fall along a line or curve. This cause analysis tool is considered one of the seven basic quality tools. In this above shown figure, the scatter for the different types of reasons for rejection is provided.

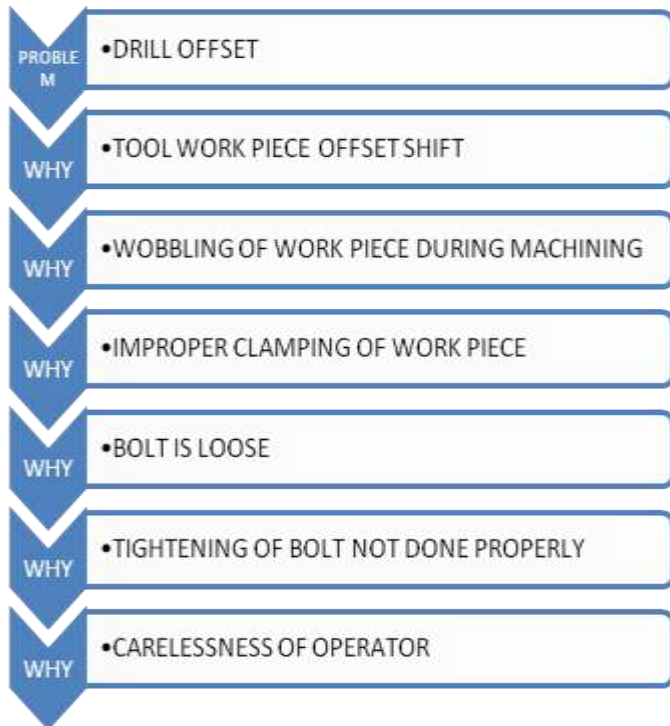
Fig-12: Why-why analysis

The above shown why-why analysis describes the causes which lead to the drill offset. From the diagram it can be noted that the main cause or reason due to the offset in drill is due to the tool work piece offset. This is further caused due to the wobbling of work piece during machining. And on identifying the reason for this it was found out to be due to improper clamping of work piece and all these were caused due to a primary reason i.e. the carelessness of the operator.

Also Due to insufficient feed	
Tool indexing	Wrong positioning of tool will damage the housing.	Tool has to be set accurately.
Operator skill	Due to absence of skill chances of accidents at operation station is more.	Operator should provide with sufficient training.
Mass rejection at final inspection	Due to ignorance of slight changes occurred. Due to not reworking the part or component which was showing a minute deviation at the earlier stages.	In process checking should be frequently done by the workers to ensure there are no high rejections at the final inspection.

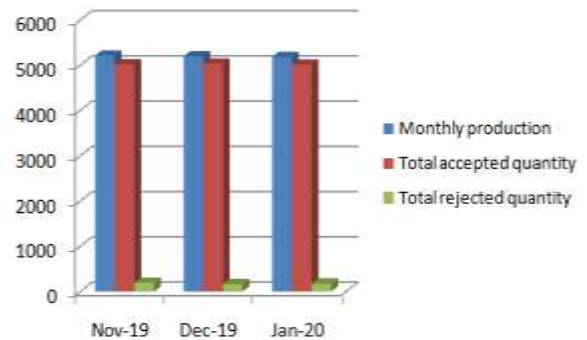
Table-3: Data collection for monthly production and rejection over the past three month (from Nov 2019 to Jan 2020)

Month	Monthly Production	Total Accepted Quantity	Total Rejected Quantity	Rej. %
Nov 2019	5212	5021	191	3.66%
Dec 2019	5196	5018	178	3.42%
Jan 2020	5184	5010	174	3.35%

Fig-13: Graphical representation

Since the blow holes and rusting together contribute to the major proportion of rejection in an advance housing, so it is necessary to study the quantity of these rejections.
