ASSESSMENT OF IMPACT OF URBANIZATION ON WATER BODIES IN CUDDALORE DISTRICT USING REMOTE SENSING AND GIS

P.Priyanka¹, S.Priyadharshini²

¹P.Priyanka: Assistant Professor, Department of Civil Engineering, IFET College of Engineering, Tamil Nadu, India.

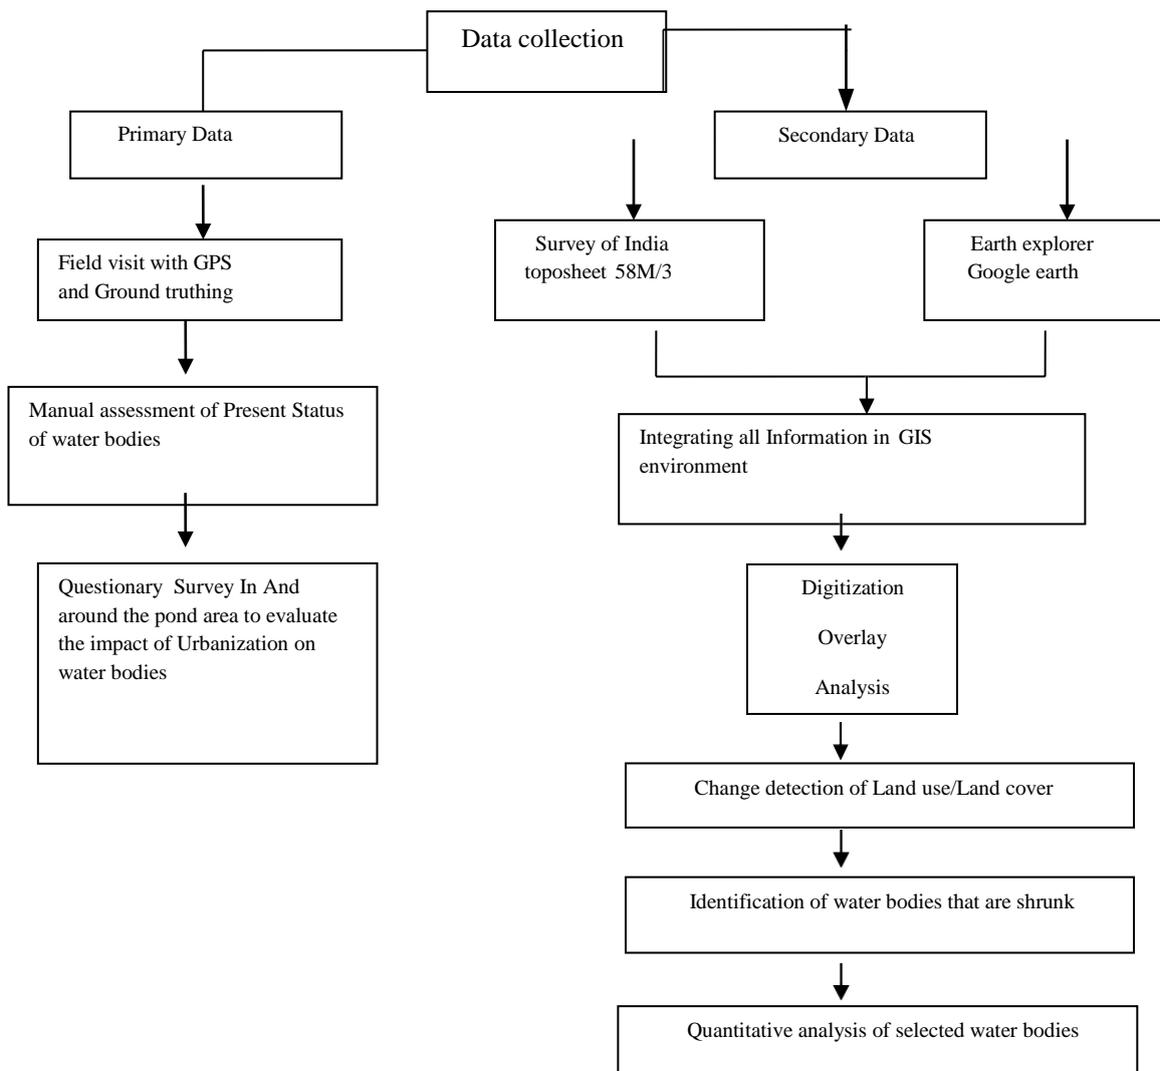
Fig 3.1 Flowchart showing the propose Methodology

The methodology is a flow chart of the work to be done to complete the project. It comprises the theoretical analysis of the frame of methods and principles associated with the project.

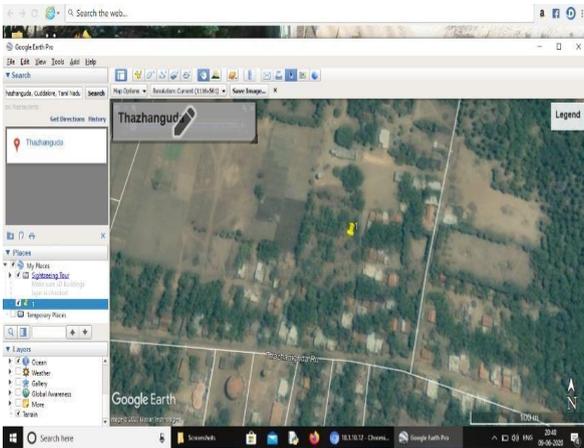
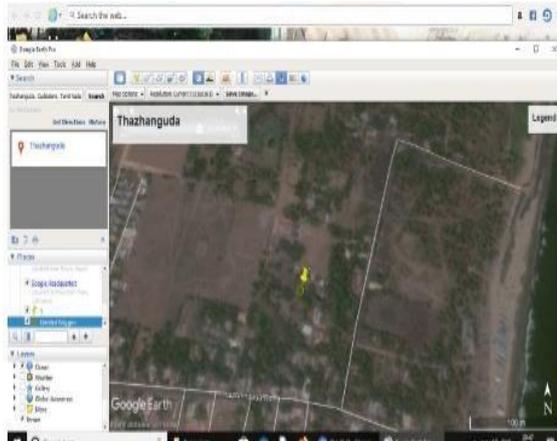
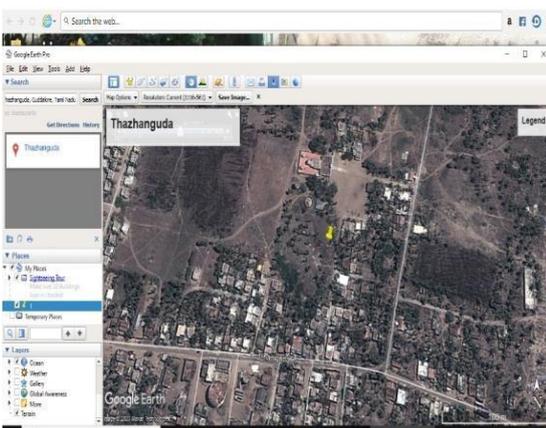
Fig 4.3a Google image of Thazhankudai of the year 1980

Fig 4.3b Google image of Thazhankudai of the year 2000

Fig 4.3c Google image of Thazhankudai of the year 2020

The images clearly indicates that the current encroachment in the pond areas of the four villages. The trace of the pond was observed by digitizing the survey of India toposheet 58M/3 by using the software arc GIS 10.2. With the help of the Google earth explorer the historical images of the study area has been recovered. It is helpful for comparing the satellite image with the geo-browser image. The ponds in the four villages namely Nathapattu, Vazhapattu, Thazhankudai, Senjikumarapuram were clearly analyzed by using Google earth explorer and the field study has been conducted to know the present status of the pond area and the present condition was mentioned. The field visit images are the evident that the water body is vanishing and shrinking because of the dumping of residential sewage and industrial waste. This has resulted in the alarming increase of acidic content in the water body which has subsequently led to the rapid growth of a defense layer of algae and weeds. The sewage water from the residential region has been noticed. This is the main reason behind the death of aquatic life in the water body. The saline, tepid, greenish water, which is home to several weeds and harmful microorganisms is totally unfit for drinking and domestic purposes. Sewage chiefly contains organic matter which promotes the growth of various micro-organisms especially bacteria. Various pathogenic bacteria are known to occur in the water at the points of sewage disposal (Tiwaari and en, 1991). The effluent from small plywood industry discharged into the aquatic system change the physio- chemical properties of water were affected. Thereby effecting the aquatic flora and fauna in general and the fish population in the particular area. The industrial effluents generally contains heavy metal which have more disastrous and long lasting adverse effects on the human health

Sl. No	Name of the village	Name of the pond	Current status of the pond	Type of Use	Description
1	Thazhankudai	Thai pond	Converted	To houses for disadvantaged groups	NA
2	Nathapattu	Pattur pond	Encroachment around the pond area	Grama panchayat Kudam Slum people houses	<ol style="list-style-type: none"> 1. Grazing and fodder collection 2. Washing of clothes and vehicles 3. Collection of leafy vegetables 4. Fuelwood collection
3	Vazhapattu	Adiyan pond	Converted	Enclosed for defense established	NA

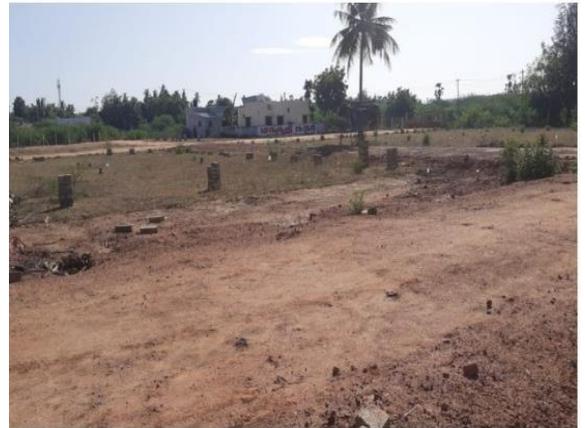
Fig 4.3 d Field Photograph of Thazhankudai

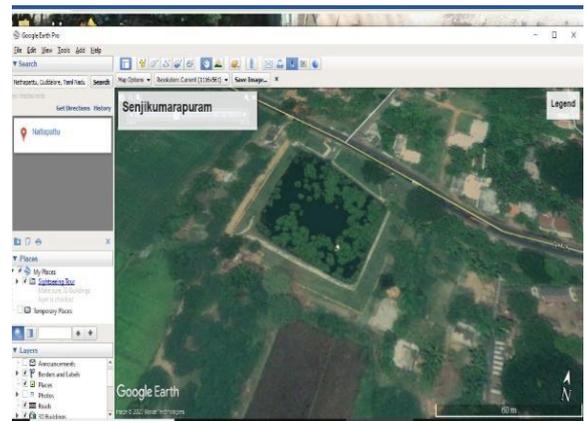
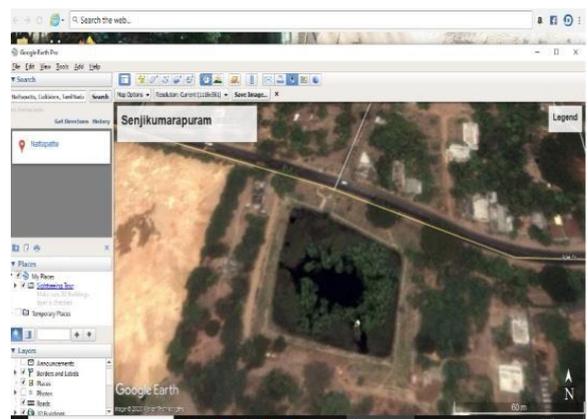
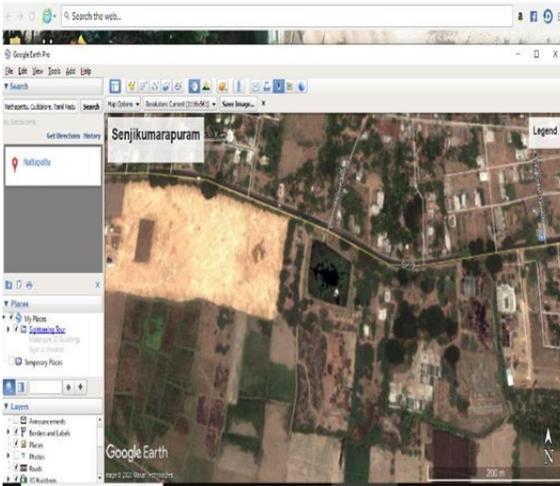
Fig 4.3e Google image of Senjikumarapuram of the year 1980

Fig 4.3f Google image of Senjikumarapuram of the year 2000

Fig 4.3g Google image of Senjikumarapuram of the year 2020

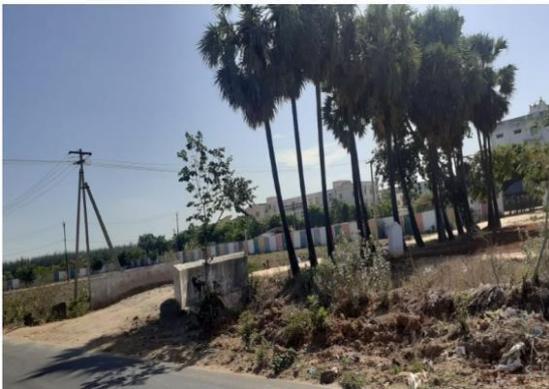
Fig 4.3h Field Photograph of Senjikumarapuram

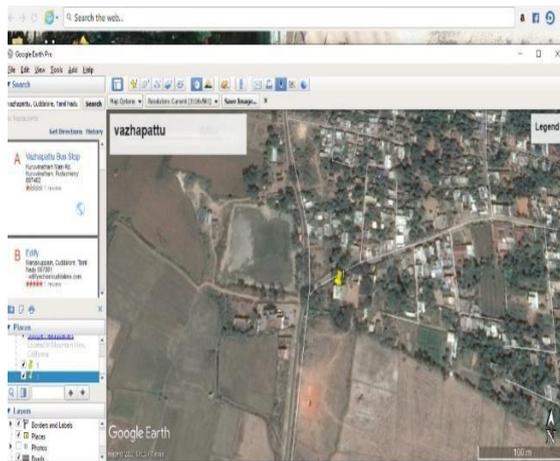
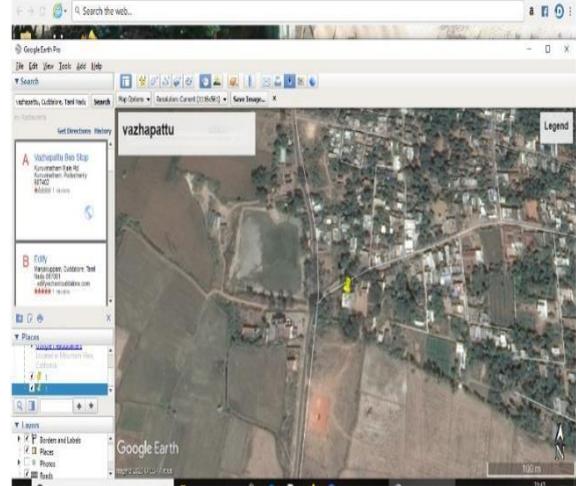
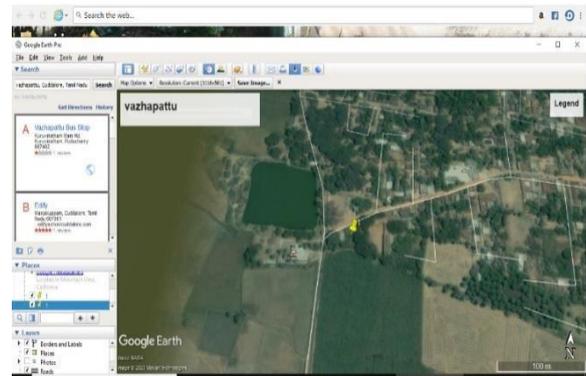
Fig 4.3j Google image of Vazhapattu of the year 2000

Fig 4.3k Google image of Vazhapattu of the year 2020

Fig 4.3i Google image of Vazhapattu of the year 1980

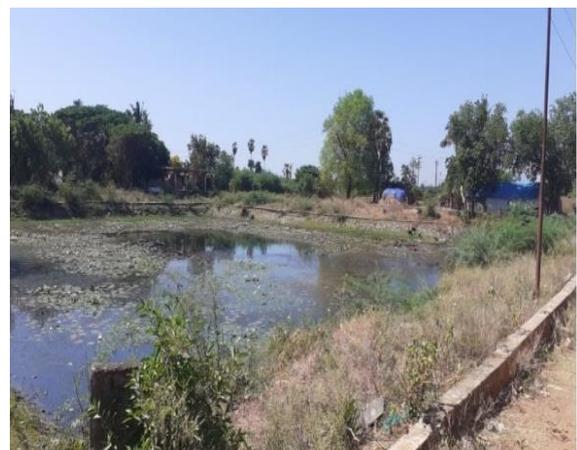
Fig 4.3l Field Photograph of Vazhapattu
