Climatic Investigation of a Contemporary Church in Kochi for Thermal Comfort

ABSTRACT: Thermal comfort studies correlate the comfort of occupants in a built environment to the functioning and energy utilization of a building. Many thermal comfort studies have been carried out in buildings that are occupied for the major portion of a day such as classrooms, offices, etc. Whereas the number of studies carried out in building typologies such as mosques, churches, etc. which are not occupied for more than four hours per day, are not many. This study was intended to analyse the thermal comfort of occupants of a contemporary church in warm- humid climate. A recently constructed naturally ventilated church, having a regular occupancy of over 1,000 people in Kochi, Kerala, was identified as an ideal case to study various climatic parameters affecting thermal comfort. The environmental factors affecting thermal comfort have been studied through field measurements and occupant satisfaction surveys. The study was carried out step by step including climate study for climate analysis, in-situ survey for short time representative quantitative evaluation and building simulation tools for a whole

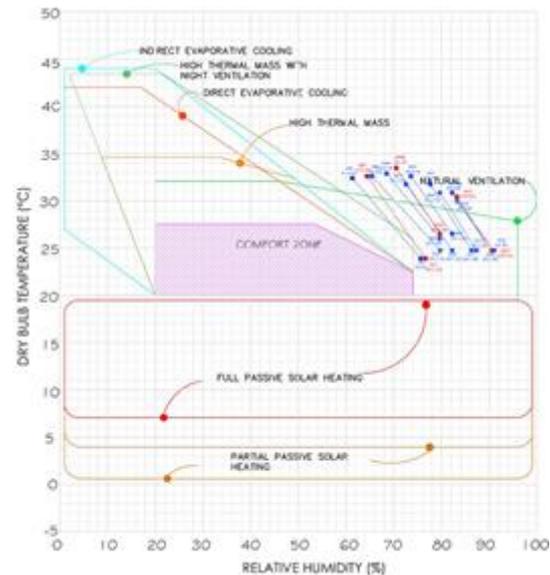
The climate of Kochi is predominantly warm and humid. The temperature ranges from a minimum of 23°C in January to 33°C in May. The temperature ranges are similar in all the months. The diurnal temperature variation is not greater than 8°C in any month. Humidity levels greater than 60% are observed throughout the year. During the monsoon months of June, July, and August, the humidity levels increase up to 91%. The prevailing wind direction is from the North West and West. (India Meteorological Department, 2015, pp. 201-202). Figure 4 depicts the bioclimatic chart of Kochi (DeKay & Brown, 2001, p. 54). From the bioclimatic chart, it can be seen that none of the months fall in the comfort zone. Due to high humidity

Figure 4 Bioclimatic chart of Kochi (Source: Author generated)

The research was carried out in many stages of primary study. From the climate study, it was found that July/August (monsoon) would be a critical month for discomfort due to high humidity levels. The bioclimatic chart of Kochi showed that none of the months falls into the comfort range. There is a need for ventilation strategies for enhancing comfort.

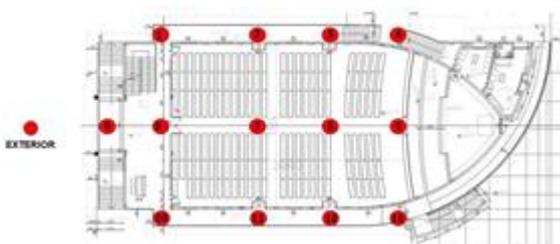
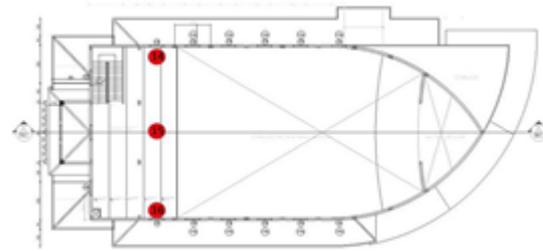
Figure 5 Measurement positions on the Ground floor

Figure 6 Measurement positions on the mezzanine floor

the interior data regarding wind speed and direction, the parameters were measured in the evening (4-6 pm) for 2 consecutive days at the selected points inside the church as seen in figures 5 and 6. It is to be noted that for taking the field readings, all the interior measurements were determined without any occupancy, at 1m level from the floor with all windows fully open during the time of measurements.

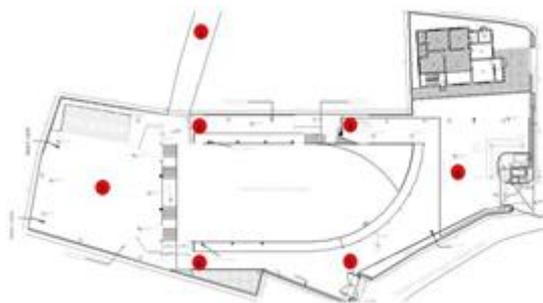
The field measurements were taken in the monsoon representative month of August 2019 for a period of 7 days. The parameters which were measured were: Ambient Temperature (°C), Relative Humidity (%), Wind Speed (m/s) and Wind Direction. A thermo-hygrometer and anemometer were used for the measurements. For the interior data for relative humidity and air temperature, the church was divided into a grid having 16 nodes as seen in figures 5 and 6, where humidity and air temperature were measured for 4 days at 3 representative times of the day- morning (8-10 am), noon (12-2 pm) and evening (4-6 pm). For exterior data, seven points were located along the site boundary as seen in Figure 7, to obtain exterior measurements of wind speed and direction for a day at 3-hour intervals in a day to find predominant wind direction on-site due to microclimatic conditions. For

Figure 7 Measurement positions on the site

From the exterior measurements at positions mentioned in Figure 7, for wind speed and direction as seen in Figures 14 and 15, it was observed that due to microclimatic conditions, the predominant wind

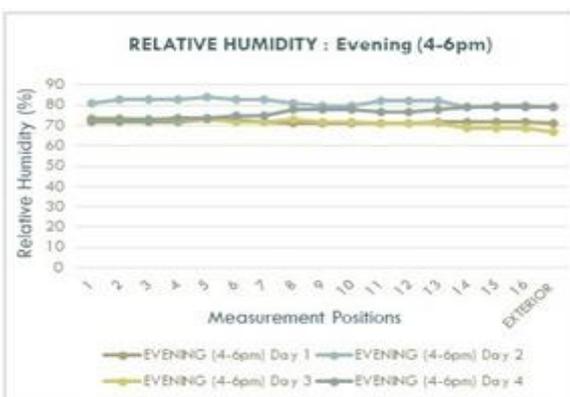
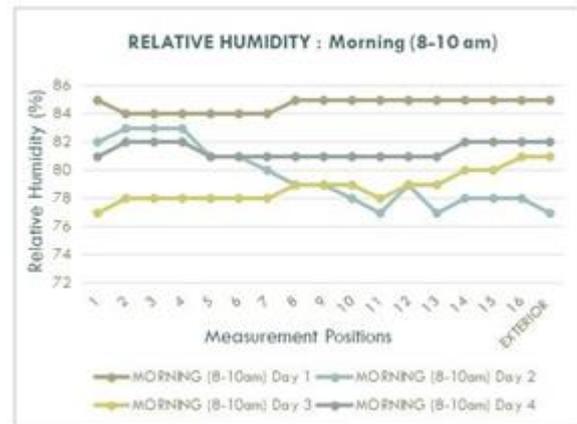
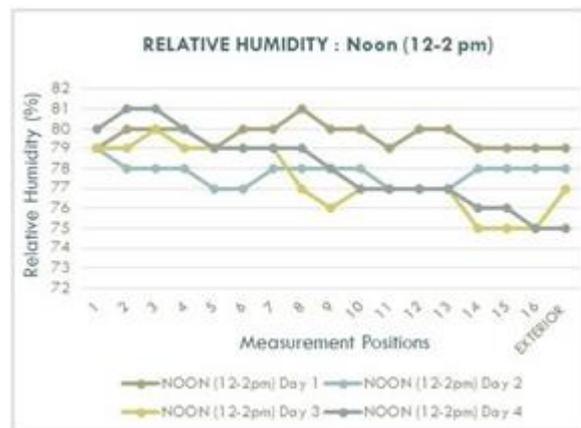
From the humidity measurements, as seen in Figures 8-10 which have the relative humidity readings on the Y axis and the measurement points on the X axis, it was observed that humidity inside the church was lesser than the IMD readings of the day. There were not any drastic changes in relative humidity at the different measurement points.

Figure 8 Relative Humidity measurements for the morning (Source: Author generated)

Figure 9 Relative Humidity measurements for the noon (Source: Author generated)

Figure 10 Relative Humidity measurements for the evening (Source: Author generated)

The field measurements of temperature and humidity showed that there is not much change in humidity readings at various points inside the church,

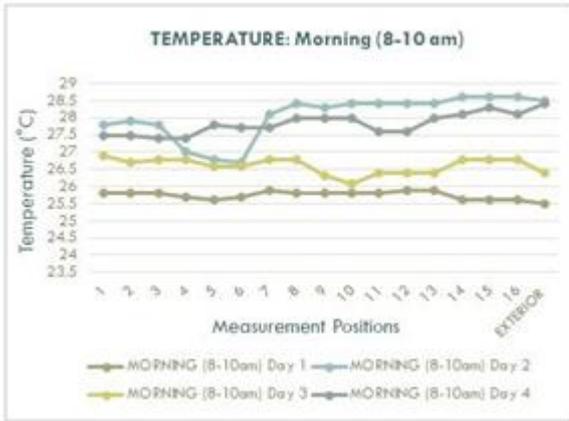
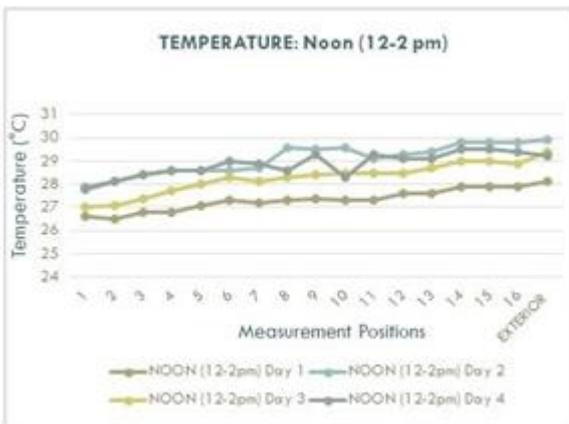
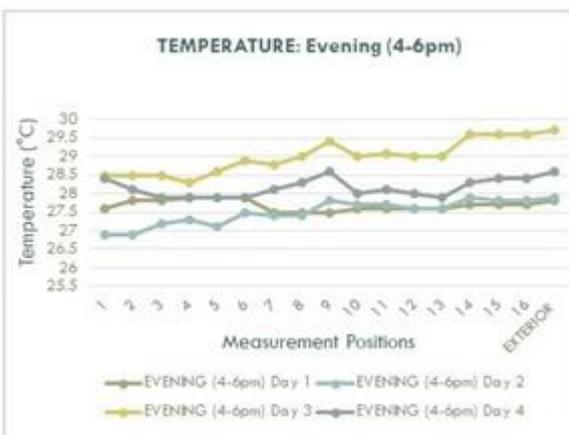
From the temperature measurements, as seen in Figures 11-13 which has temperature readings on Y axis, it was observed that temperatures at the mezzanine floor were higher than the ground floor.

Figure 11 Temperature measurements for the morning
 (Source: Author generated)

Figure 12 Temperature measurements for the noon
 (Source: Author generated)

Figure 13 Temperature measurements for the evening
 (Source: Author generated)

whereas the temperatures on the mezzanine floor were considerably higher. The onsite predominant wind direction was found to be from South West and West (during the days of the study) and not from North West as per the IMD climate data. The wind speeds inside the church were found to be very low (up to 0.3 m/s) which is not sufficient for comfort conditions as per Beaufort scale.

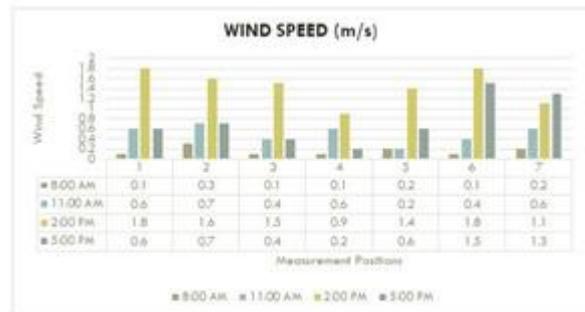
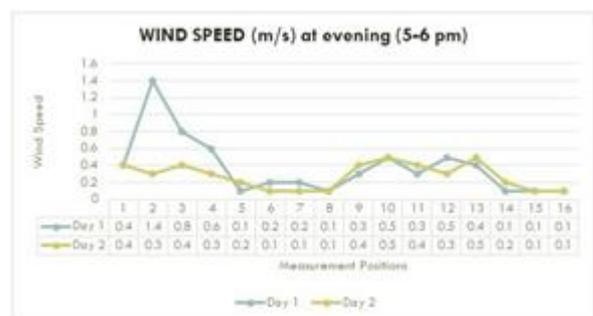
direction was from South West and West (during the days of the study) and not from North West as per the IMD climate data.

Figure 14 Graph depicting the wind speed on the various points outside the church for measurement timing at 3 hour intervals.
 (Source: Author generated)

WIND DIRECTION					
POSITION	8:00 AM	11:00 AM	2:00 PM	5:00 PM	PREDOMINANT
1	↗	→	↓	→	W →
2	→	→	→	→	W →
3	←	←	→	↓	E ←
4	↖	↑	↑	↑	S ↑
5	↖	↖	→	↑	SE ↘
6	↗	↑	→	↗	SW ↘
7	↗	↗	↘	→	SW ↘

Figure 15 Wind direction at the various points outside the church for measurement timing at 3 hour intervals. (Source: Author generated)

From the interior measurements for wind speed and direction, as seen in Figures 16 and 17, it was observed that the air velocities near the windows of the church were maximum 0.4m/s and only up to 0.3m/s at the points inside the church without any

occupants. As per Beaufort scale wind speed of 1.6 - 3.3 m/s is required for wind to be felt on the face for comfort.

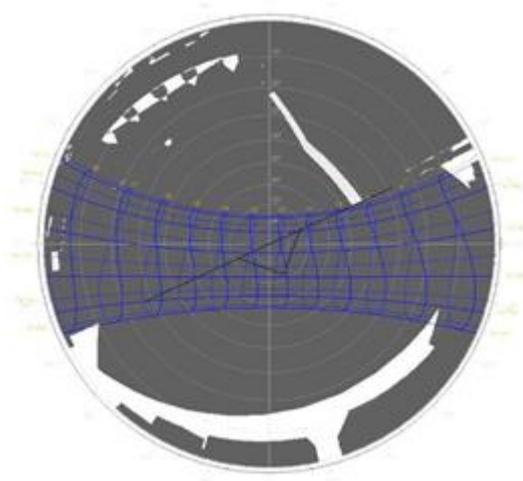
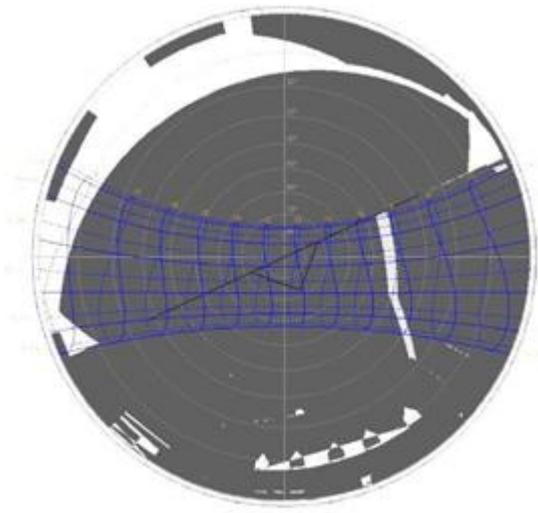
The solar shading analysis of the church was done for an entire year on Autodesk Ecotect Analysis 2010. This was done to understand if the openable windows at the accessible height on the North and South façade were receiving direct radiation, especially during the morning hours.

From the shading analysis, it was understood that the operable windows meant for ventilation were being shading during the daytime, throughout the year.

Figure 26 Stereographic diagram of solar shading of a window on South façade (Source: Author generated)

Figure 27 Stereographic diagram of solar shading of a window on North façade (Source: Author generated)

The whole year solar shading was analysed for the façades of the church. It was observed that due to the shaded wide corridors on either side of the church, the windows at the ground floor were getting shaded throughout the year. Thus, radiative heat gain is not a factor that can be a cause of discomfort. The wind flow analysis done for a day considering the wind speed and direction obtained from the field measurements, further validated the on-site readings. The simulation showed that due to adjacent buildings and the orientation of the church, the wind flow was diverted from the rear side. Thus, significantly reduced the air movement inside the church which is a major parameter of the thermal comfort of occupants.

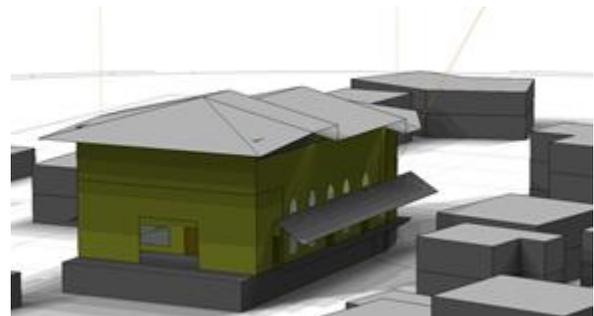
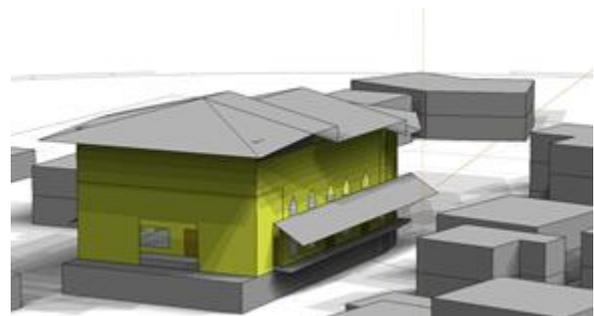
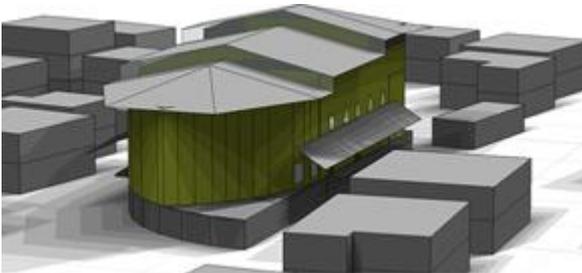
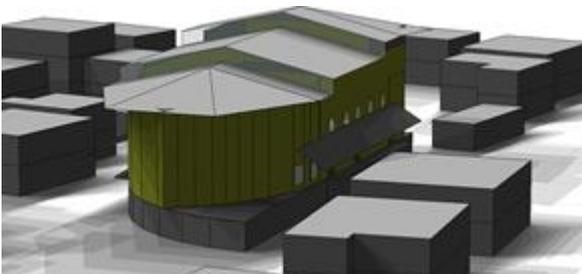
Figure 28 Shadow range on South Facade for April (Source: Author generated)

Figure 29 Shadow range on South Facade for December (Source: Author generated)

Figure 30 Shadow range on North Facade for April
 (Source: Author generated)

Figure 31 Shadow range on North Facade for December
 (Source: Author generated)

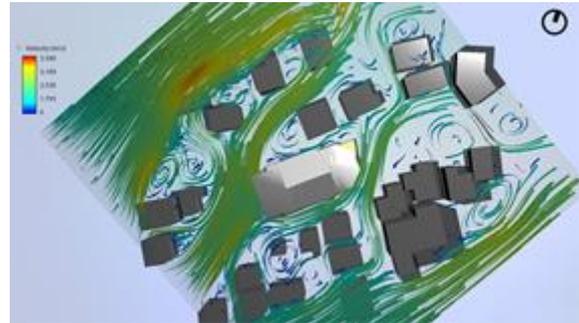
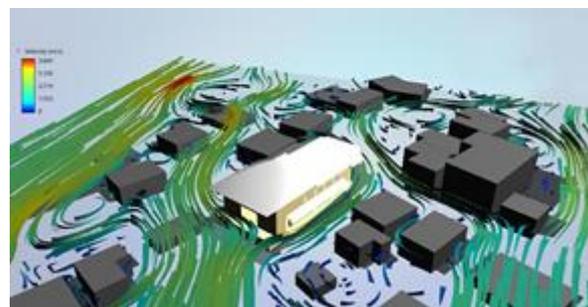
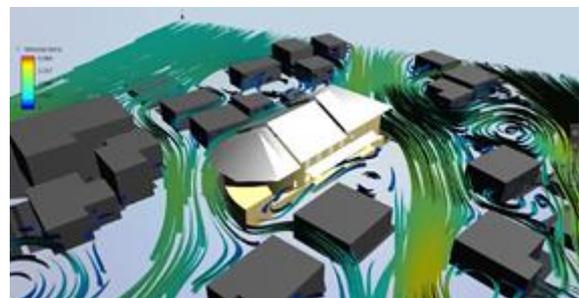
Due to dense development, the velocity of wind on site is less than 1.2m/s. Due to the adjacent buildings, the orientation and shape of the church, the wind flow gets diverted from the West side. Hence, the amount of ventilation happening from the side facades is minimal. This analysis is thus correlating with the on-site measurements which showed that inside the church the wind speeds reduced to 0.1-0.3m/s.

Figure 32 Wind flow analysis – Plan (Source: Author generated)

Figure 33 Wind flow analysis around the South façade (Source: Author generated)

Figure 34 Wind flow analysis around the North façade (Source: Author generated)

The air movement around the church was simulated using Autodesk Flow Design software. The airflow was simulated at 1m/s and the direction was taken from the South West as these were the predominant speed and wind direction obtained from the field measurements. The simulation was carried only for a representative day of the field measurement to check if the field readings and simulations for that day were correlating. The wind flow for analysis was taken at the 4m from the ground level, which is the height of the occupant seating inside the church.
