# Case Study of Structural Rehabilitation of Multi Storey Residential Building

**Abstract** - Although the RCC structures are designed as per codes not always constructed properly using correct techniques and methods. As a result, the structures start showing signs of distress which requires repair and rehabilitation work. In this project, a case study of (G+7) multistoried building whose ground floor was damaged due to the flood of 2006 has been represented. The repair strategy was to assess the quality of structural members of the ground floor of the building with the help of Non-Destructive and Semi Destructive Tests such as Rebound Hammer, UPV and Concrete Core Test. All the flood-affected members were tested and proper treatment to each of them was applied such as anticorrosion coating, injection grouting, micro concreting and also jacketing of columns at ground level. Strict quality control in materials and workmanship was adopted. All the rehabilitation work was done to increase the durability and service life of the building. After the engagement of all the professionals and cooperation of the residents for rehabilitation work was carried out. Some of the recommendations a

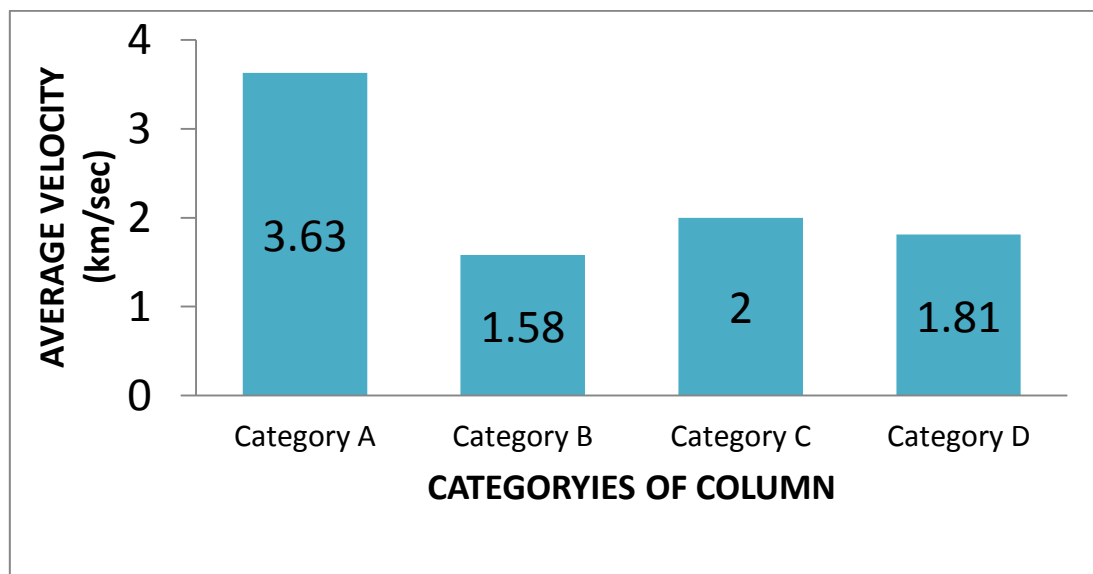
Table 5 Analysis of UPV test

- Category D members have low strength compare to category A members, as pulse velocity obtained from UPV test is 10-15% lower for category D members.
- Bottom portion(up to 1m from ground) of category B members are weaker than top portion of the columns, as pulse velocity obtained from UPV test is 50-55% lower for bottom portion.
- Moreover, bottom portion(up to 1m from ground level) of category B members has pulse velocity 45-50% lower than category A members and this indicates flood damage.
- Category C members have low strength compare to category A members, as compressive strength obtained from Rebound Hammer test is 30% lower than average.

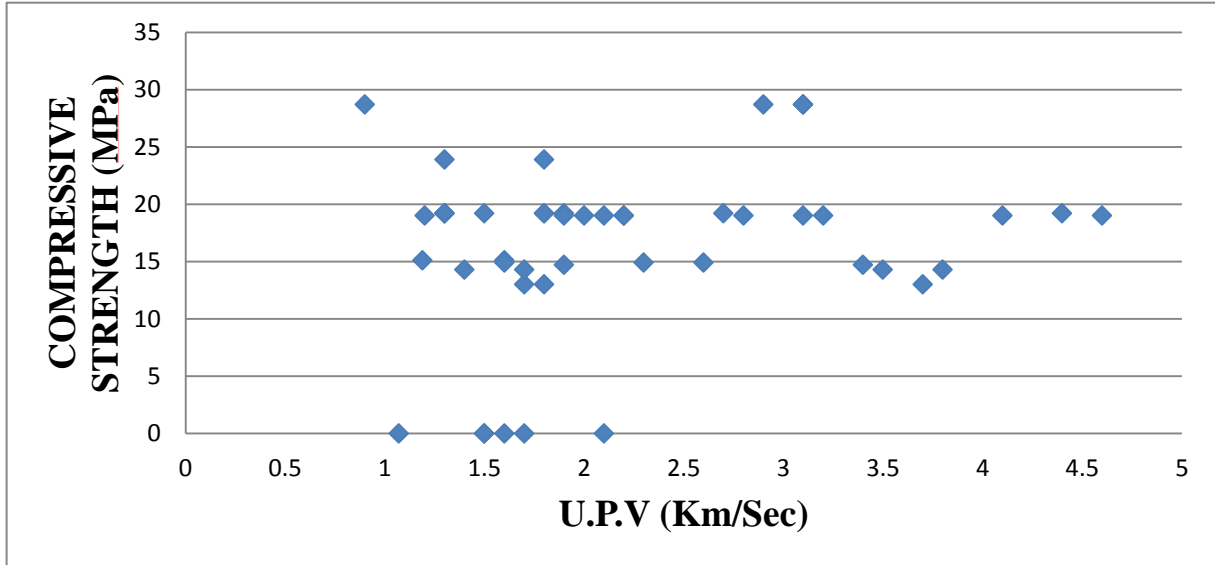
Table 7 COMPRESSION STRENGTH VS UPV

- Comparative compressive strength of category A members is noted 45-50% higher than category B members.
- For category B columns compressive strength of bottom portion(up to 1m from ground level) is noted 20-25% lower than top portion(above 1m from ground level) of respective columns.
- Comparative compressive strength of category A members is noted 5-10% higher than category D members.
- As per testing results slabs and beams are found in good condition.
- These results obtained from tests will help in performing Push over analysis which is essential for further repair and rehabilitation of the building.

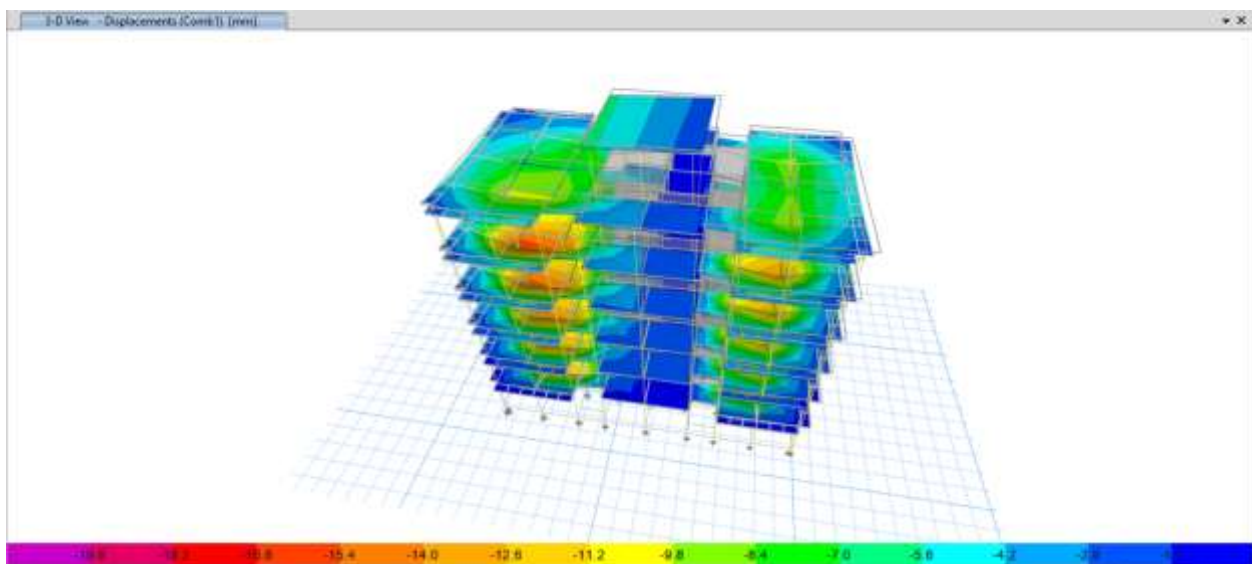
*Figure 4 ETABS Analysis*

- Based on the analysis of the multi-storied building, the following conclusions are made:
- This analysis was performed just for informational purpose.
- Steel data was not available, so an around 2.5% steel of total cross section of the column was considered for analysis.
- The analysis did not show any structural failure.
