# Detection and Identification of Gear Teeth Damage through Sound and Vibration Signal Analysis of Austempered Ductile Iron Gear

**Abstract** - Gearbox is a key part of any machinery and to make sure it runs at peak condition it is subjected to condition monitoring. The purpose of this project is to study vibration and sound characteristics for austempered ductile iron (ADI) gear. The experiment is conducted for healthy and faulty gears at various loading condition and speed. The gear fault selected for this experiment is broken teeth. The data is collected with the help of data acquisition system (DAQ). The input to DAQ are accelerometer, microphone, order tracking devise and impact hammer. The output of the DAQ is connected to the system. The procedure for finding the defective gear in a gearbox is by compare the data acquired of the gearbox with healthy and defective gear. The data is collected and processed using time domain analysis, frequency domain analysis, angular domain analysis (order analysis) and sound analysis. The result for broken teeth shows the increase in vibration amplitude at 1st gearmesh frequency (GMF) with the presence of natural frequency both in Fast Four

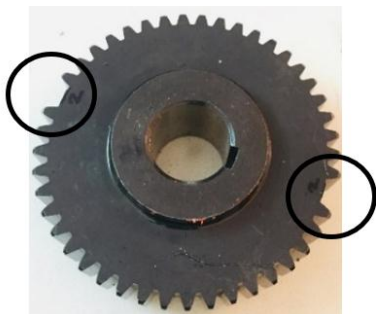
**Fig -2:** ADI gear with removed teeth

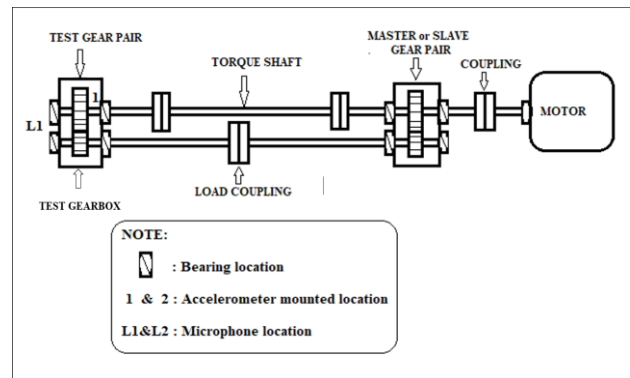
**Fig -3:** Schematic representation of gearbox test rig.

The gearbox test rig used to conduct this experiment is power recirculation type. The test rig mainly consists of a motor to rotate the gearbox, a load coupling to apply load on to the gearbox and a set of gearboxes assemble. The test gears are fitted at test gearbox as shown in figure 3. The figure 4 shows the setup used to conduct the experiment.

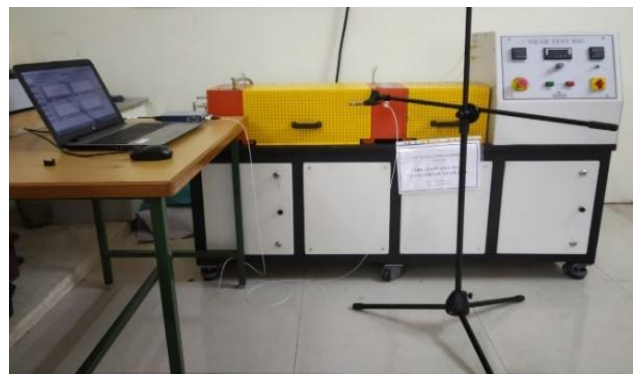
**Fig -4:** Experimental setup of gearbox test rig.

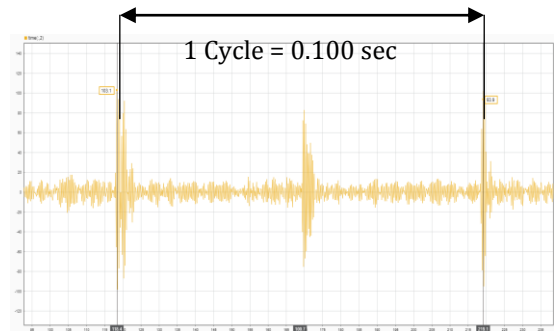
Fig -10: Time domain data faulty gear for 600rpm

The time taken to complete one cycle for 600rpm is 0.100 sec (Note: 600/60 = 10 Hz; 1/10Hz = 0.100 sec.). The figure 8 and 9 shows that there is periodic peak at an interval of 1 cycle. When comparisons is made between the faulty gear and healthy gear the presence of peaks in faulty gear is clearly visible.

If we further look into the time domain data of faulty gear (figure 10) we can see that there is a 2<sup>nd</sup> peak between the cycle. So, for every cycle there is two peaks which leads to the conclusion that there are there are two broken teeth. The spacing between there two peaks are equal this shows that they are opposite to each other.

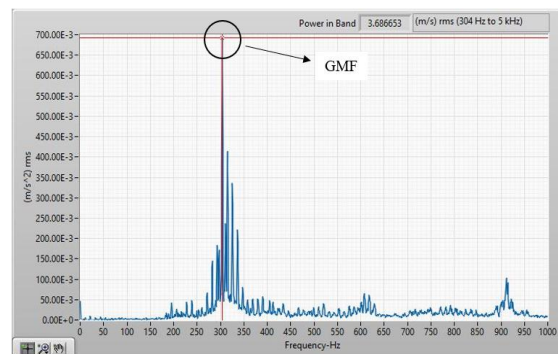
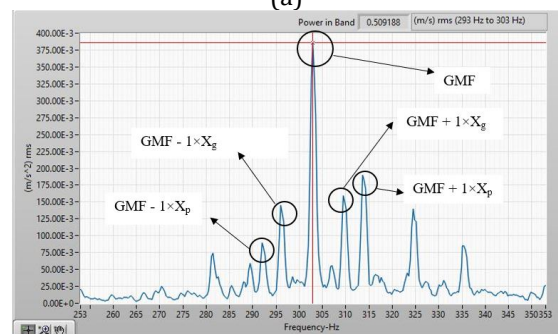
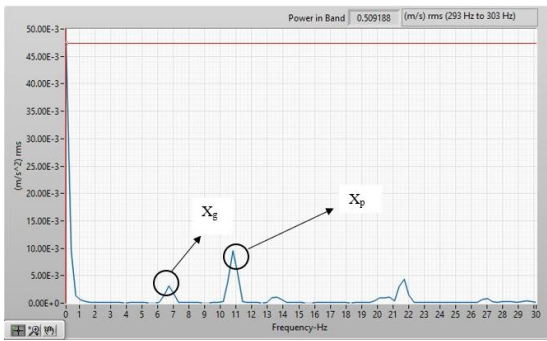
**Fig -11:** (a) Typical FFT spectrum of healthy gear, (b) Zoomed FFT spectrum near 1st GMF, (c) Zoomed FFT spectrum near gear and pinion rotational frequency.

Frequency domain analysis is done using fast Fourier transform (FFT). In a Typical FFT four fundamental frequency of gear analysis can be observed. Gearmesh frequency (GMF) in figure 11(a), Sidebands of GMF in figure 11(b), Rotational frequency of gear and pinion in figure 11(c) and last is natural frequency which is visible when there is defect figure 13.

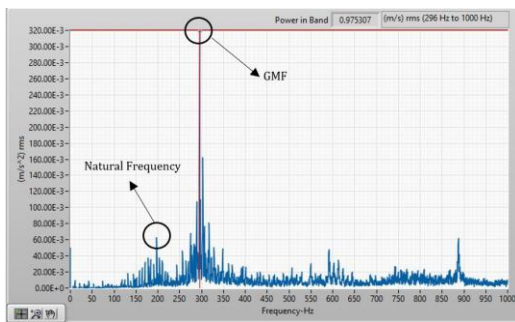
**Fig -12:** Defect gear FFT spectrum for 393.661rpm at 41.6925 Nm

The figure 12 and 13 represent Defect gear FFT spectrum for 393.661rpm at 41.6925 Nm. In figure 11 there are two peaks one representing GMF = 295.24575 Hz and the other natural frequency. In the zoomed spectrum of figure 13 the natural frequency is clearly visible at 197 Hz.

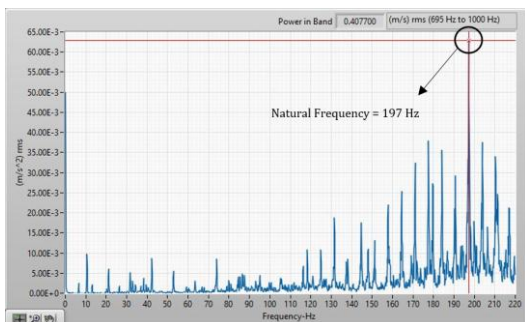
**Fig -13:** Zoomed defect gear FFT spectrum for 393.661rpm at 41.6925 Nm

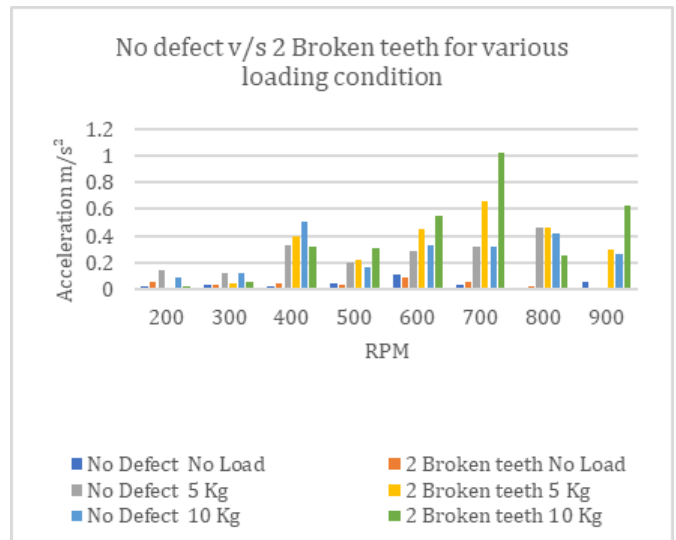
The figure 14 shows that the amplitude of vibration for broken teeth gear is more than that of the gear with no defect for majority of cases. There is also increase in vibration as we increase load and RPM.

**Fig -14:** No defect v/s 2 broken teeth for various loading condition

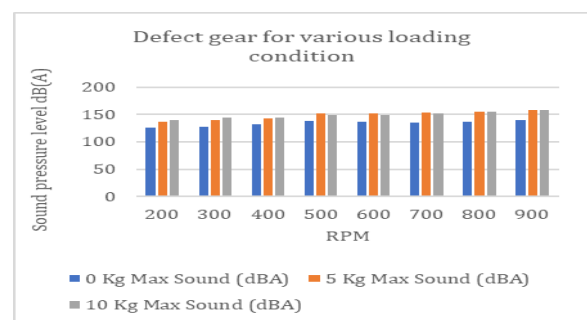
Fig -21: Defect gear for various loading condition

When the comparison is made between healthy and faulty gear for various running speeds there is increase in sound pressure level for faulty gear from 500rpm (figure 20). The figure 21 shows the increase in sound pressure level when load is applied to faulty gear. Also, the increase in sound pressure level for 5kg to 10 kg is very low.

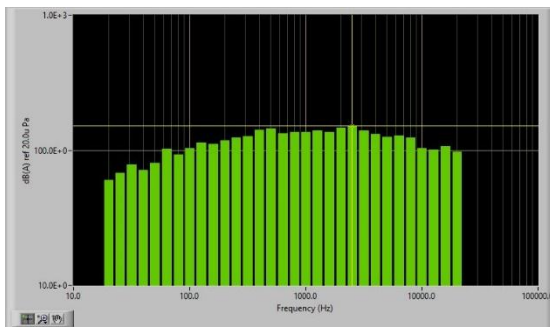
**Fig -22:** Sound pressure level for 600 RPM, 5Kg load, in 1/3 octave sound analysis (a) Healthy gear (b) Faulty gear
