RISK ANALYSIS AT SHIP TO SHORE (STS) CRANES IN CONTAINER TERMINAL OPERATIONAL SYSTEM OF A GREENPORT USING FAILURE MODE AND EFFECT ANALYSIS

Debrina Puspita Andriani¹, Sugiono²

^{1,2} Department of Industrial Engineering, Universitas Brawijaya, Malang 65145, Indonesia

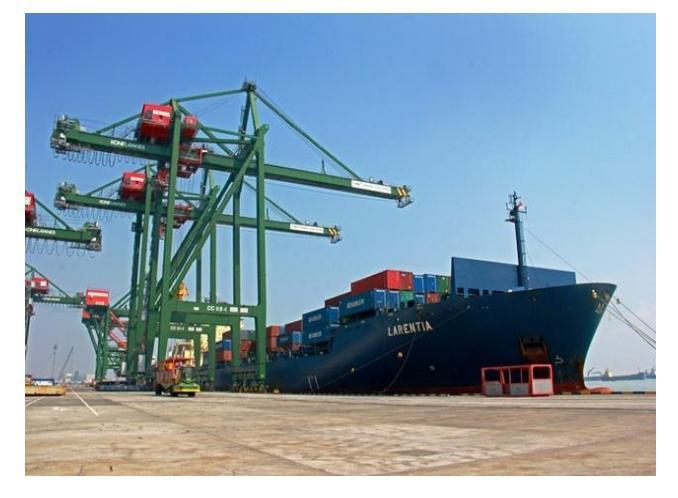
Fig -2: Ship to Shore (STS) Cranes

The following stage describes the results of this study, which consists of the stage of determining the organizational context, risk identification, risk analysis and evaluation, and action planning on risk. The company serves as a port that serves domestic containers, international containers and dry bulk with food standards. The terminal capacity reaches 342,000 domestic container TEUs and 435,000 TEUs of international containers. Meanwhile, dry bulk capacity is 2000 ton/hour. This terminal is regarded as the most sophisticated terminal in Indonesia and first use the automatic operating system and apply the concept of green port. In line with the increasing interest of service users using loading/unloading services make the company continue to equip the to environmentally friendly terminal with new international facilities and equipment such as Ship To Shore (STS) Crane used in loading and unloading activities at the container port (Figure 2). STS Crane International specification has a boom of 30-40 meters so it can be used to serve Panamax type ships and able to lift loads up to 60 tons with twin lift system (able to lift containers 2 x 20 feet simultaneously).
