# Vehicular Delay at Pedestrian Crossing Due to Non-Synchronized Pedestrian Signal

**Abstract** - There are many factors for the delay of the vehicle on the road, some of these are controllable and some cannot be controlled. Fixed time pedestrian crossing signals can be controlled to reduce the vehicular delay on the stretch. This study is focused on the synchronization of the signal at the pedestrian crossing and nearest signalized intersection at sector 10-16 of the Chandigarh city. Unnecessary red time faced by the vehicles at the pedestrian crossing during the green phase of the intersection is considered as the delay time for the vehicles. Average 45% of the green phase for the vehicles was found delayed due to this pedestrian crossing.

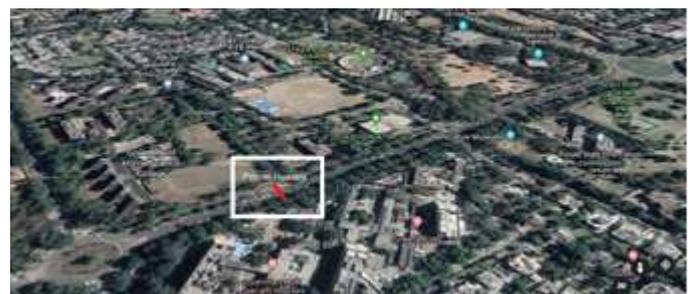
**Fig -1:** Satellite view of the site selected for the study

Chandigarh consist of major arterial roads which serves the major institute and commercial area of the city, Madhya Marg is one of the V2 roads of the city which serves important route of the city to connect with major hospitals like PGI and civil hospitals and other educational institutes. Madhya Marg is one of the busiest roads in the city. This road is selected for the study because only this stretch has installed a pelican on it in between the Matka chowk and junction number 18 chowk.

Considering the movement of the traffic towards sector 15-11 as route no. 1 and towards the sector 9-17 as route no. 2.
