# A REVIEW OF LIBERIA'S WATER RESOURCES: THE QUALITY AND MANAGEMENT WITH PARTICULAR FOCUS ON FRESHWATER RESOURCES

Prof. Dr. Hüseyin Gökçekuş<sup>1</sup>, Asst Prof. Dr. Yousef Kassem<sup>2</sup>, Francis Surfia Dioh<sup>3</sup>

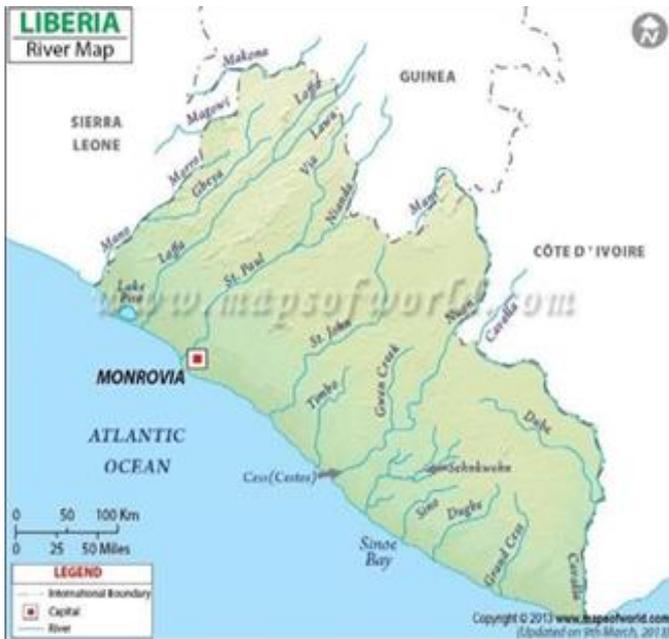
Figure3. Liberia Rivers map

Surface water is water in rivers, lakes, or freshwater wetlands. It is naturally replenished by precipitation and loss through discharge to the ocean, evaporation, and subsurface seepage. In Liberia, precipitation is the essential patron of water to surface water bodies, taking care of surface water bodies through run-off, which thus is administered by the consolidated impact of evapotranspiration and precipitation occasions. Liberia's surface water, including wetlands, represents around 14% of the nation's all-out region. Mano, Lofa, St. Paul, Cestos, Cavalla, and St. John waterways are the six significant streams of Liberia that help the watersheds. The Mano and Cavalla bowls are shared by Sierra Leone and the Ivory Coast, separately, while the Lofa, St. Paul, and St. John channel spaces of Guinea. The Border Mountains are the wellspring of a few waterways. St. John, Cestos, and Cavalla Rivers stream from Nimba Mountain; Lofa River streams from Wologizi; Mano River comes from Mano Mountain; and River Nuhn streams from Putu Mountain, bringing about jewel stores on the banks of the Mano, Cestos, St. John, and Lofa Rivers. Liberia has 15 significant waterway basins that channel to the Atlantic Ocean from the upper east toward the southwest. North of 600,000 hectares of freshwater wetlands, 55,000 hectares of beachfront mangroves, and three of Liberia's five Ramsar locales can be found in Liberia's seaside marshes. The two biggest lakes are Lake Piso and Lake Shepherd, with Lake Piso being the country's biggest Ramsar site. Liberia's just eminent repository, the Mount Coffee Dam, holds 239 million cubic meters (MCM) of water from the St. Paul River. The dam is a significant wellspring of drinking water for Monrovia and is utilized to create civil power.

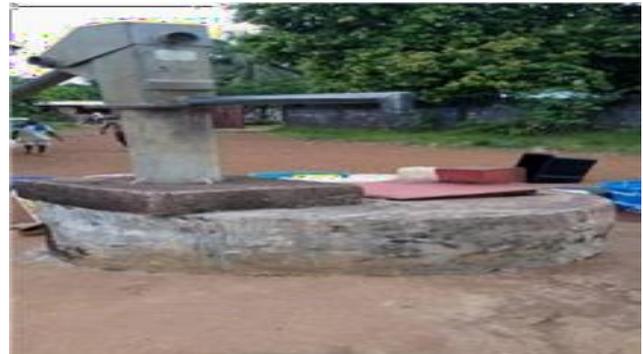
Figure 5 Borehole well

Groundwater is freshwater located in the pore space of soils and rocks, it is also water that flows in aquifers below the water table. In Liberia, groundwater is found in aquifers, which are water-bearing rocks with hydraulic properties that allow large amounts of water to be collected through boreholes and dug wells. Groundwater resources are not well understood but it is a principal source of drinking water, particularly through shallow, hand-dug wells. Assessment of aquifers and hydrological characteristics are limited, however, groundwater is the primary source of drinking water in rural and urban areas and is used by 70% of the population. In many rural and peri-urban populations, shallow wells are the principal source of groundwater collection. Groundwater levels are shallow, ranging from less than a meter in coastal locations to a few meters inland. In communities, hand-dug wells are shallow (up to 10-m depths) and completed 1–2 m below the water table. Boreholes (drilled wells) are bored to a depth of 5–100meters. Most city water frameworks were harmed during the civil wars, which constrained many people to get water through shallow, hand-dug wells.
